**KANDİLLİ OBSERVATORY AND EARTHQUAKE
RESEARCH INSTITUTE**

***May 19, 2011 KUTAHYA-SIMAV
EARTHQUAKE***

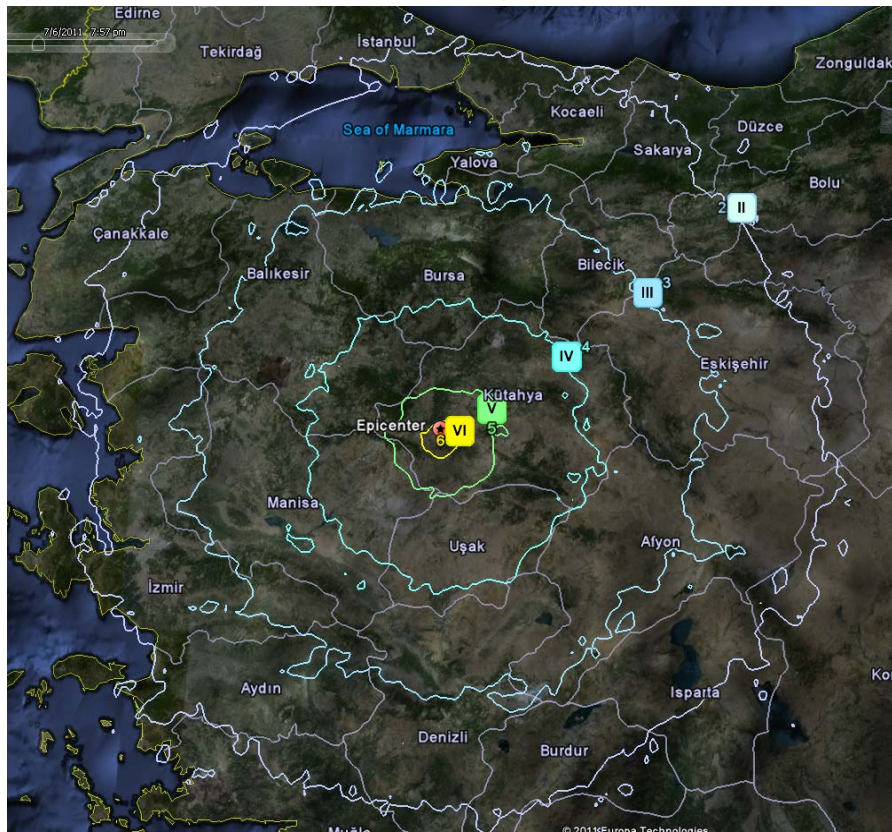
Figure 2: Intensity distribution at large scale

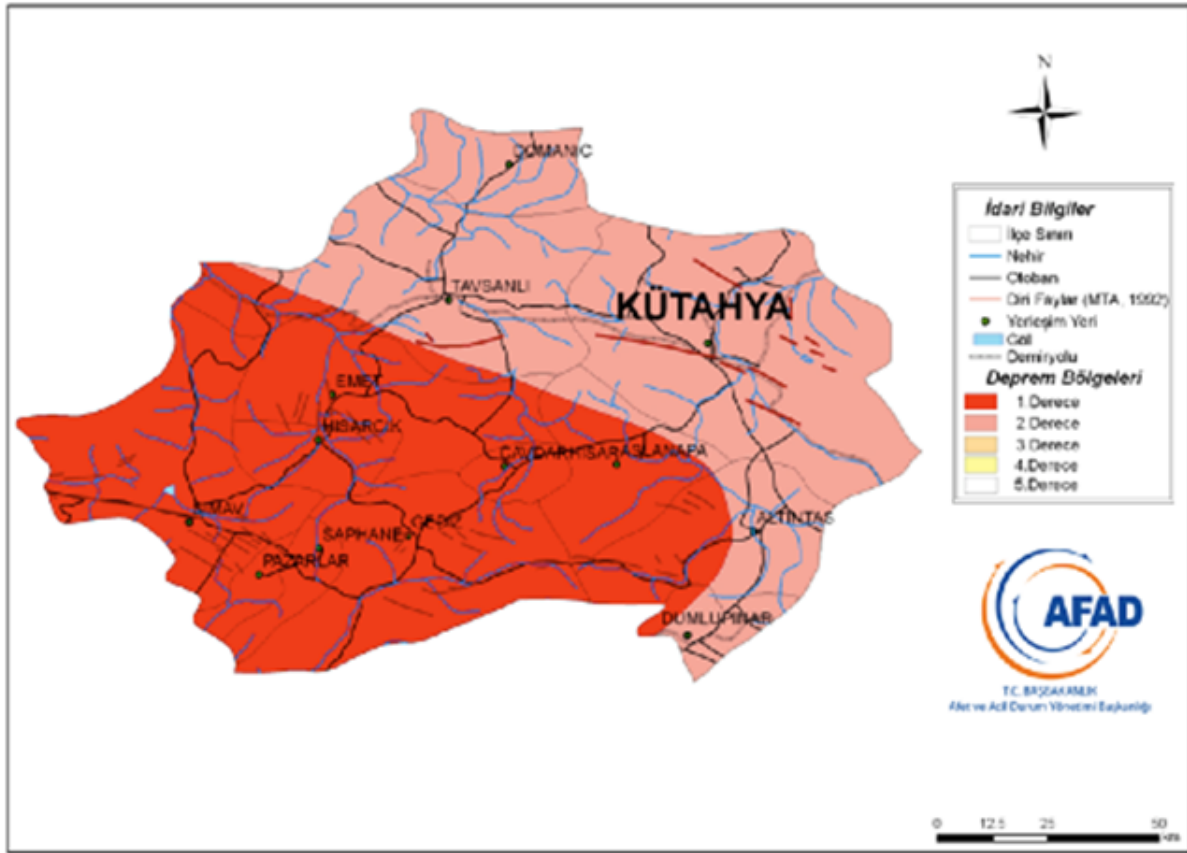
Figure 3: Seismic zonation of Kütahya province

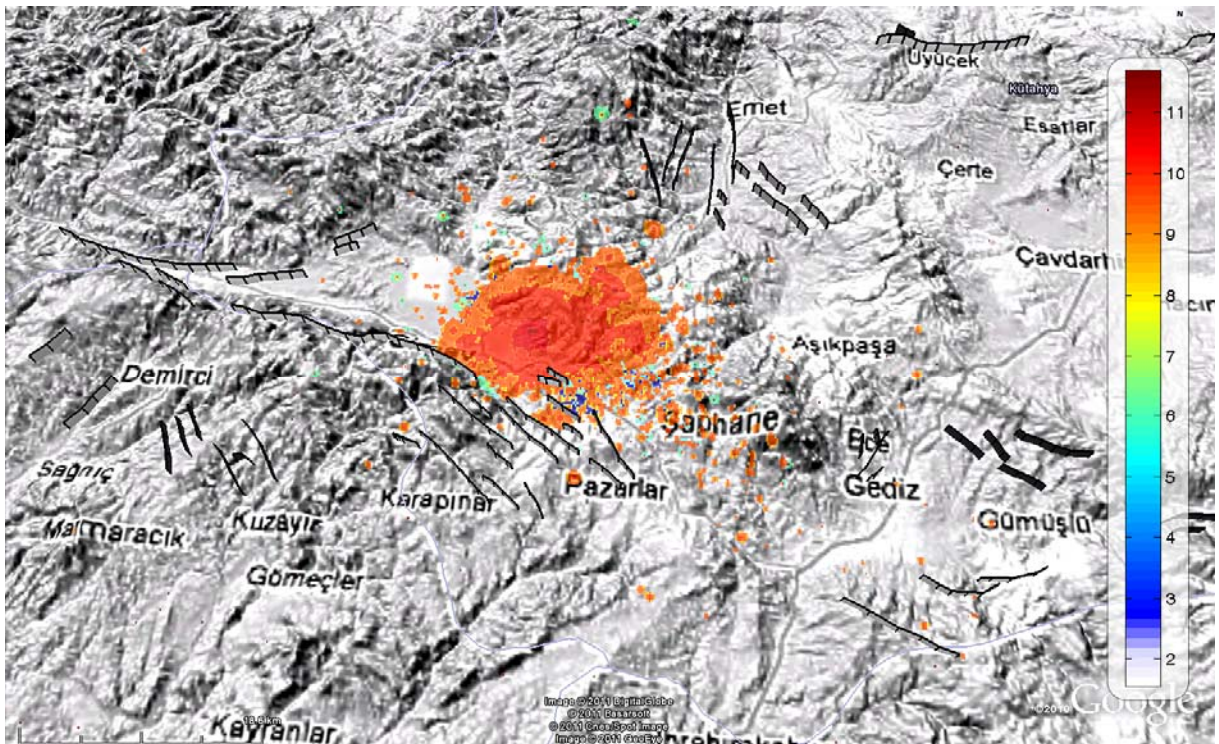
Figure 10: Surface distribution of energy released in the aftershocks

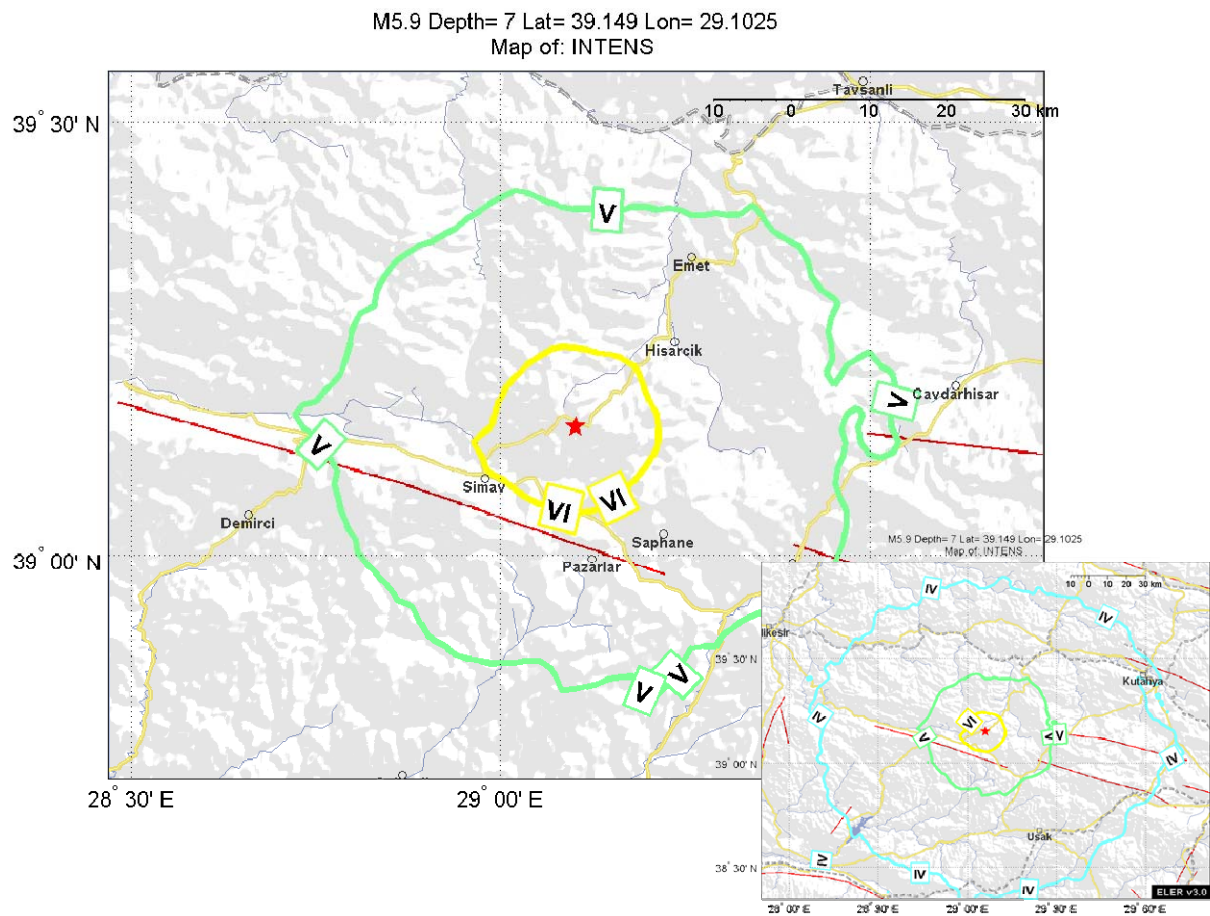
Figure 11: *Estimated intensity maps at different scales*

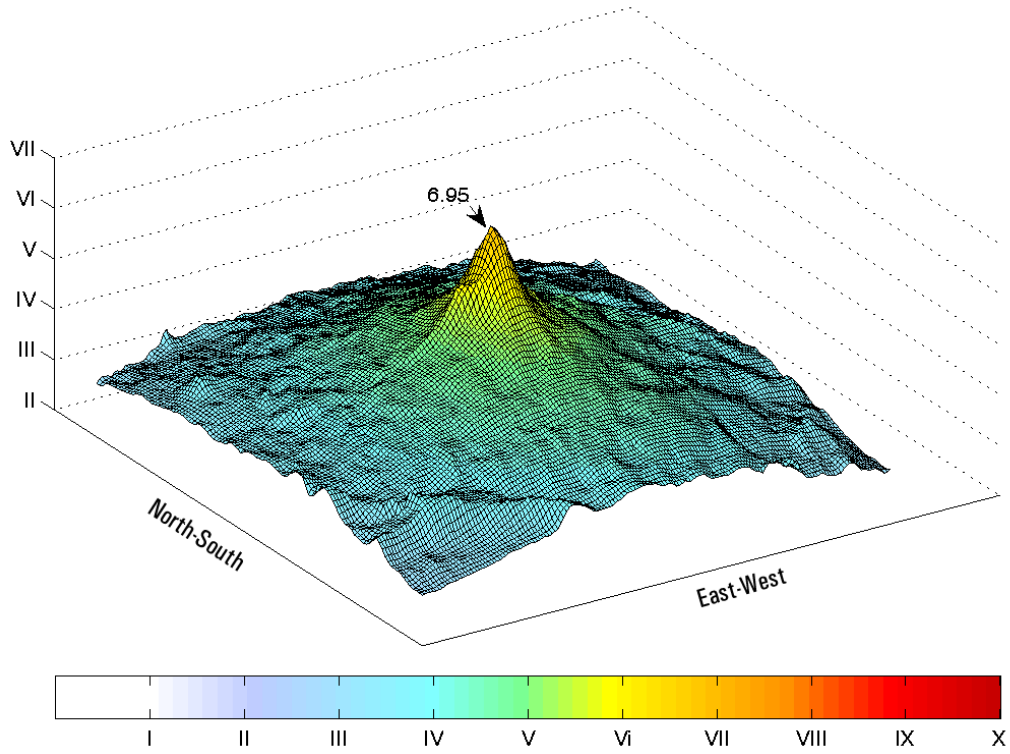
Figure 12: Estimated Intensity Distribution Surface

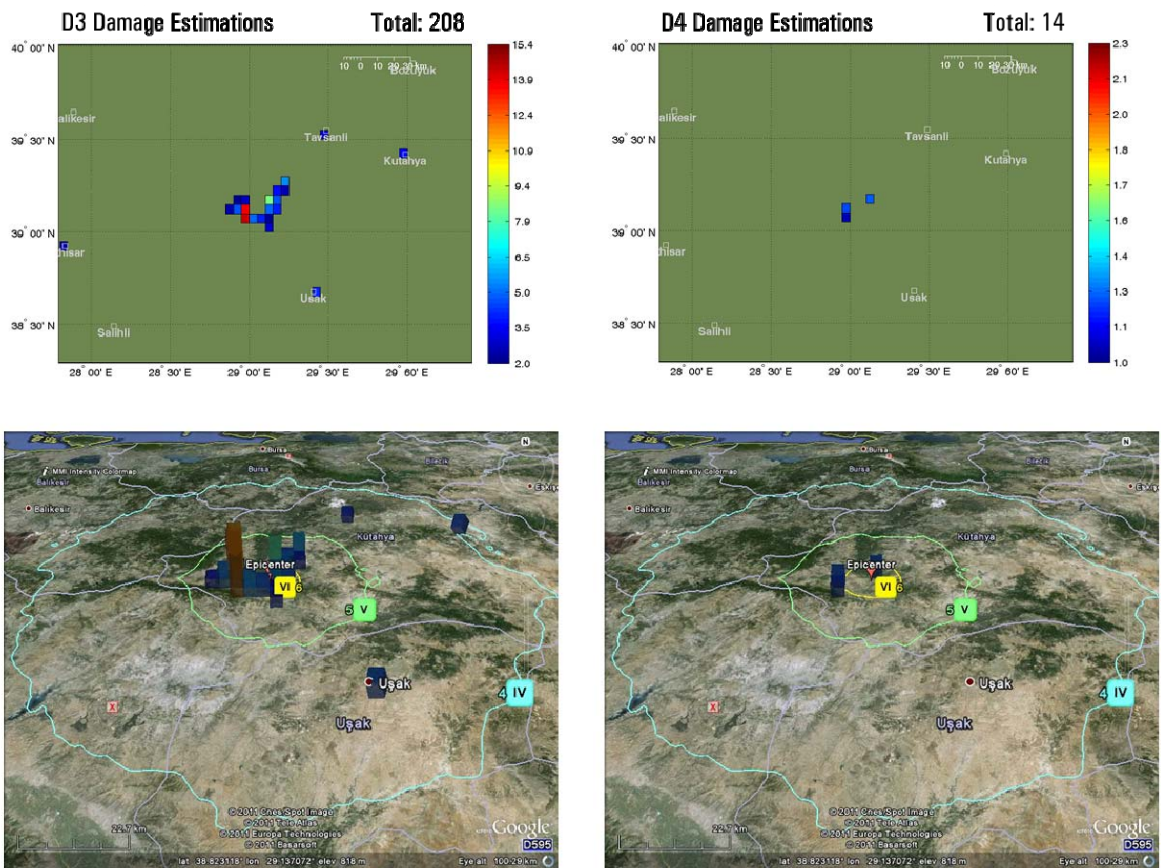
Figure 13: Distributions of Damage Classes D3 and D4

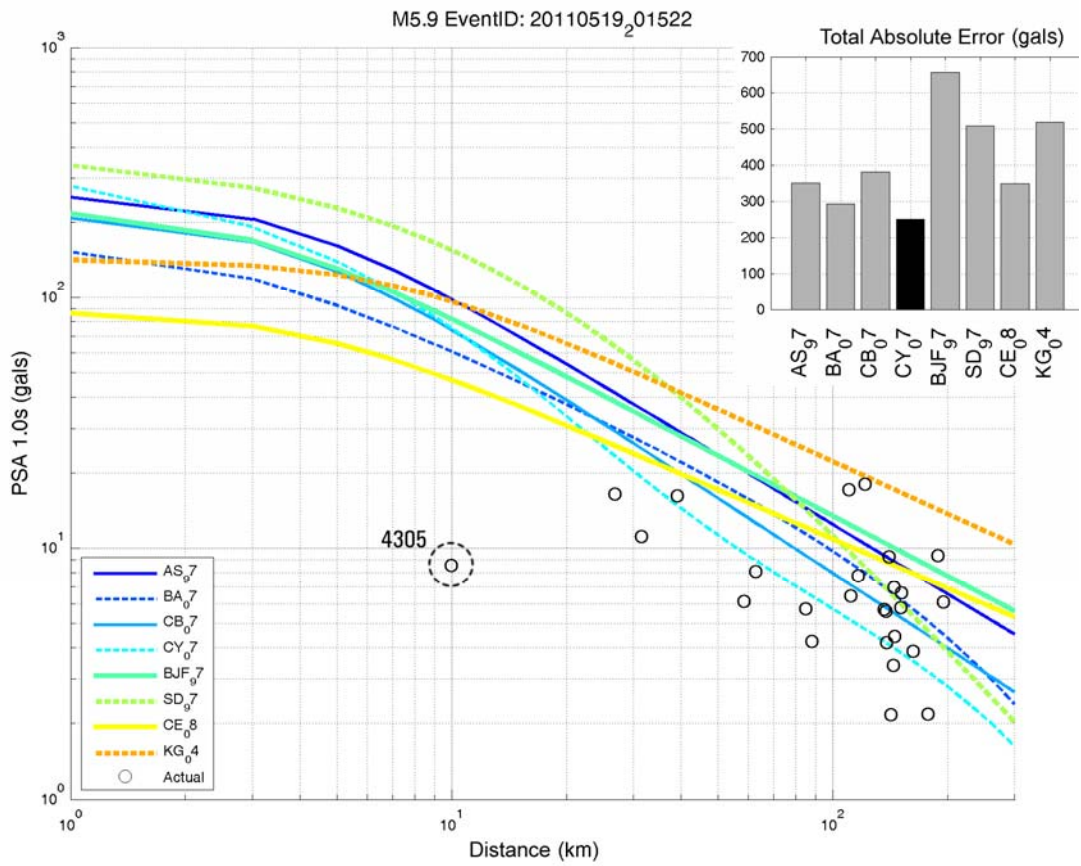
Figure 18: Comparison of actual PSA 1.0s values with GMPEs

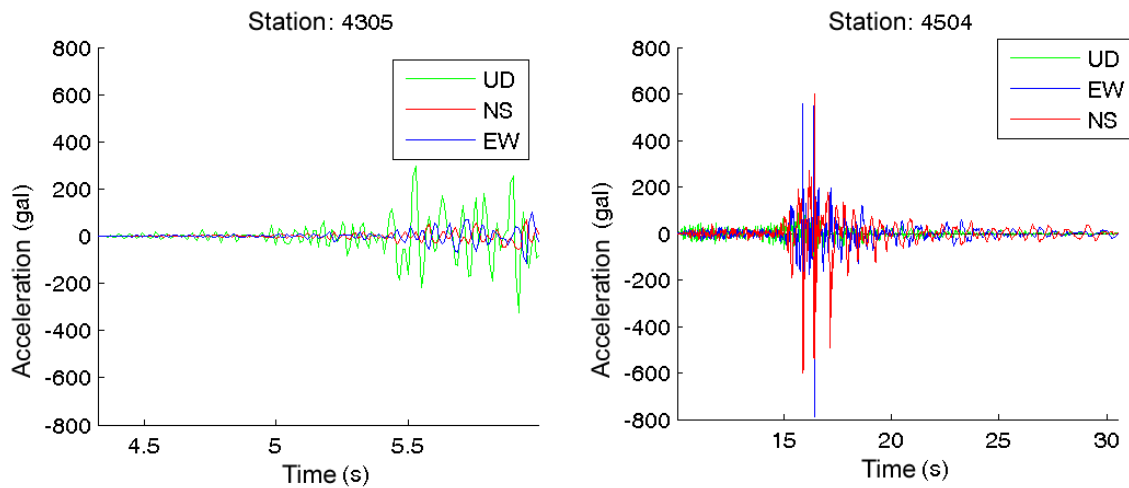
Figure 19: Acceleration-time records of stations 4305 and 4504

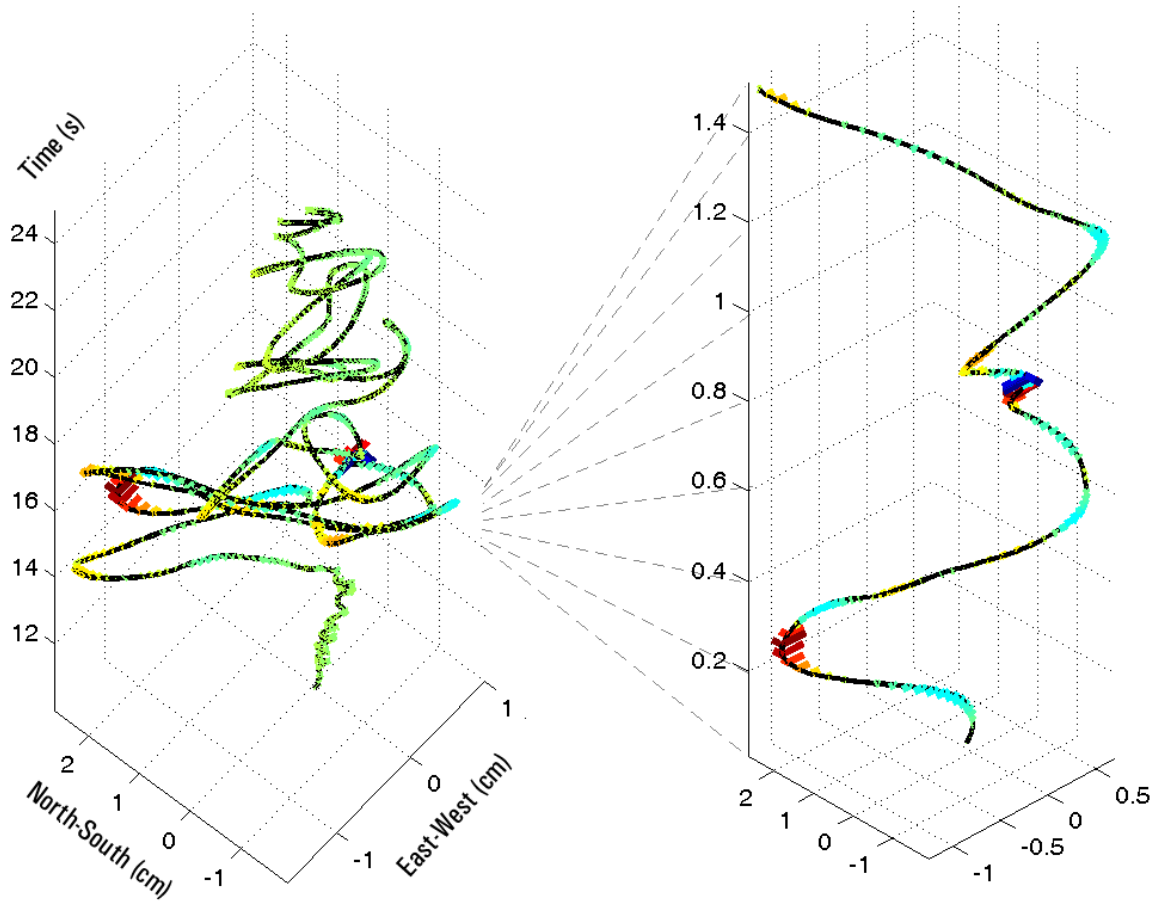
Figure 21: Free particle motion diagram of station 4504

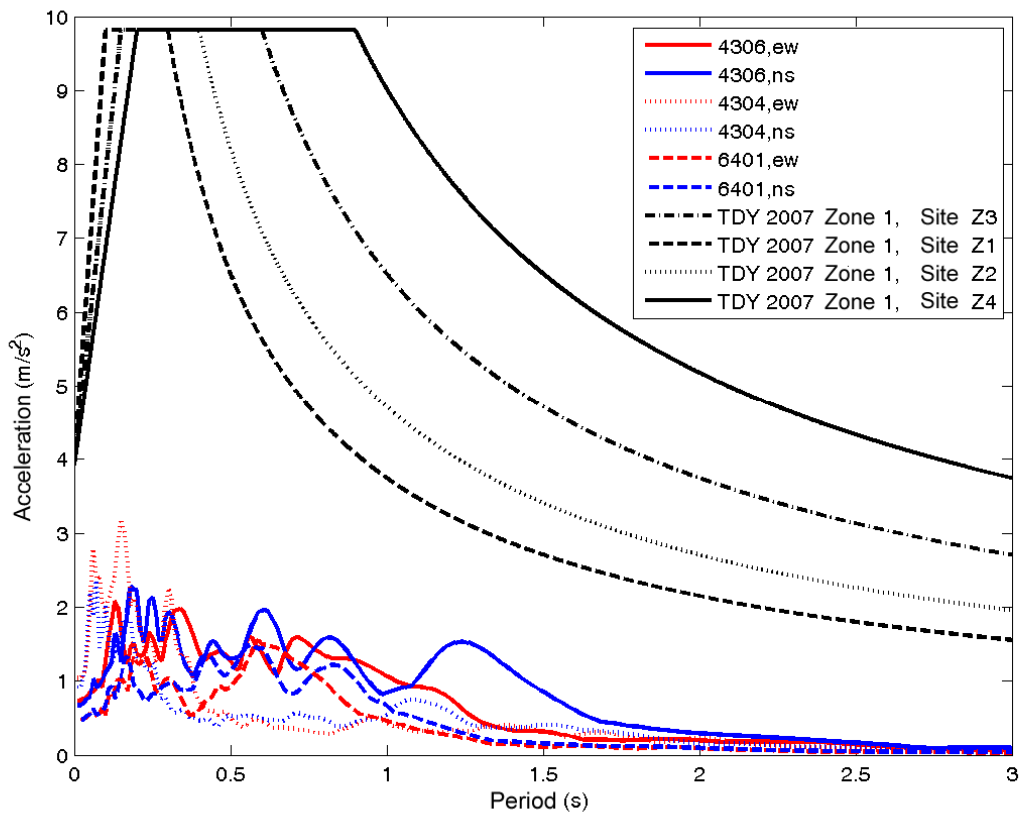
Figure 22: Response spectra compared with TSC 2007

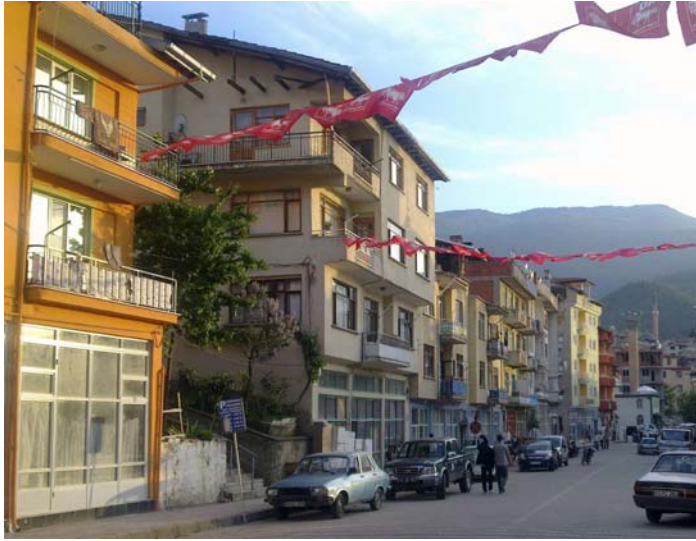
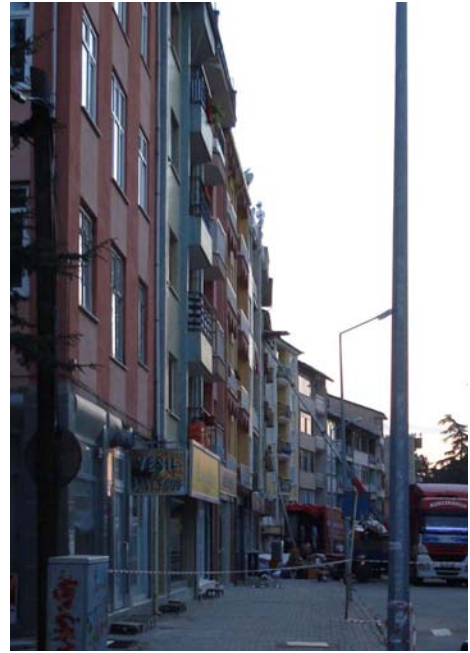
Figure 27: *Buildings adjacently constructed in town center - 2*

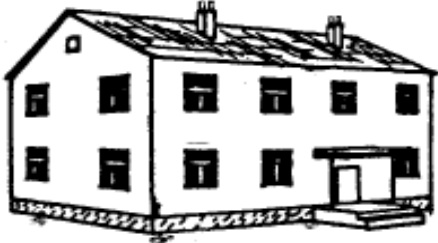
| | <p>Grade 1: Negligible to slight damage (no structural damage, slight non-structural damage)</p> <p>Hair-line cracks in very few walls. Fall of small pieces of plaster only. Fall of loose stones from upper parts of buildings in very few cases.</p> |

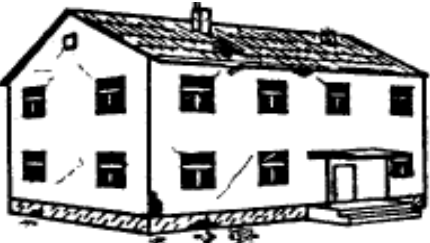
| | <p>Grade 2: Moderate damage (slight structural damage, moderate non-structural damage)</p> <p>Cracks in many walls. Fall of fairly large pieces of plaster. Partial collapse of chimneys.</p> |

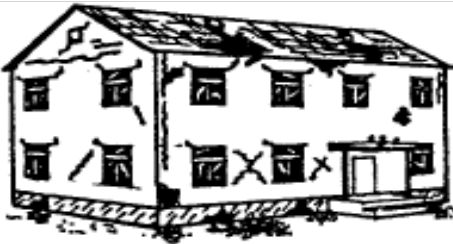
| | <p>Grade 3: Substantial to heavy damage (moderate structural damage, heavy non-structural damage)</p> <p>Large and extensive cracks in most walls. Roof tiles detach. Chimneys fracture at the roof line; failure of individual non-structural elements (partitions, gable walls).</p> |

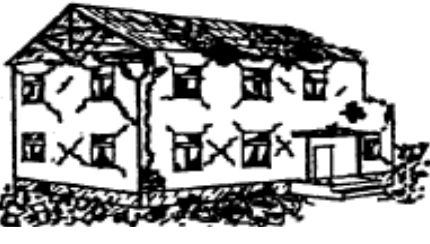
| | <p>Grade 4: Very heavy damage (heavy structural damage, very heavy non-structural damage)</p> <p>Serious failure of walls; partial structural failure of roofs and floors.</p> |

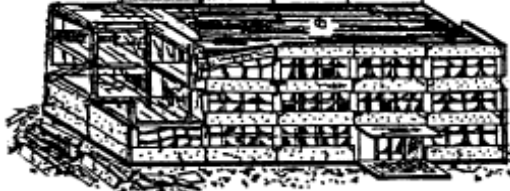
| | <p>Grade 4: Very heavy damage (heavy structural damage, very heavy non-structural damage)</p> <p>Large cracks in structural elements with compression failure of concrete and fracture of rebars; bond failure of beam reinforced bars; tilting of columns. Collapse of a few columns or of a single upper floor.</p> |

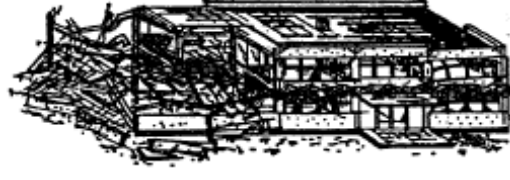
| | <p>Grade 5: Destruction (very heavy structural damage)</p> <p>Collapse of ground floor or parts (e. g. wings) of buildings.</p> |

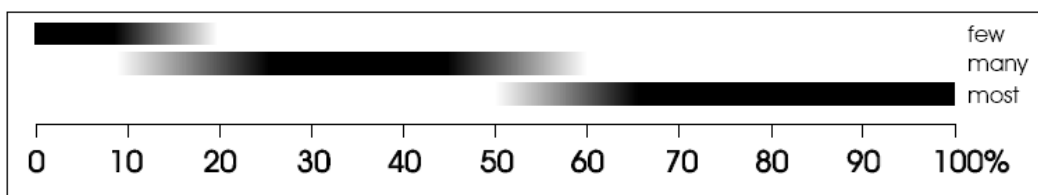
Figure 46: Quantifying amount of damage; ratio of damaged buildings of a particular level over all building stock

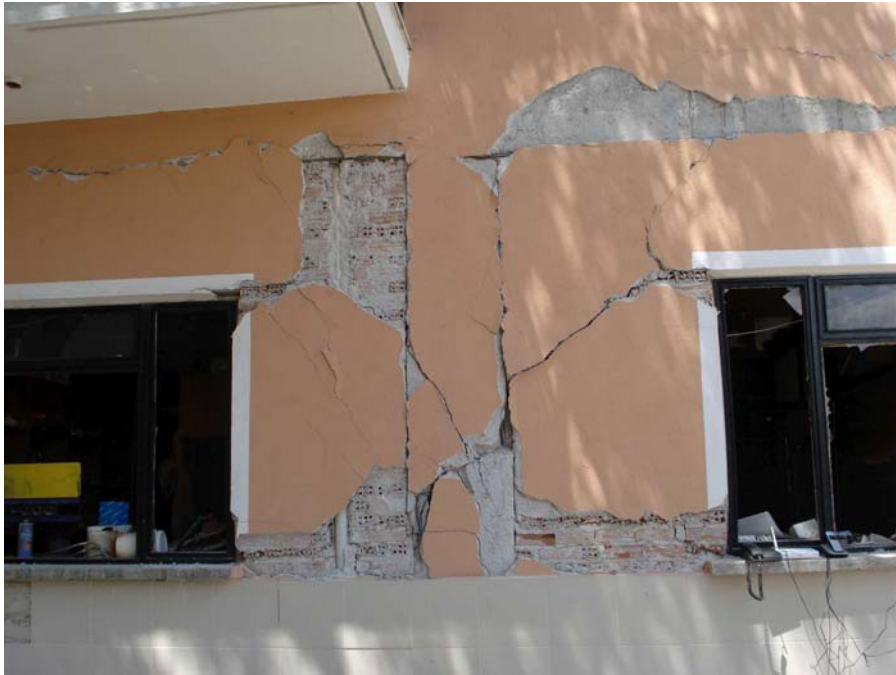
Figure 52: *One of few examples for heavy structural damage, column behaved as a short column ,infill walls were composed of fired structural bricks instead of standart infill wall bricks.*

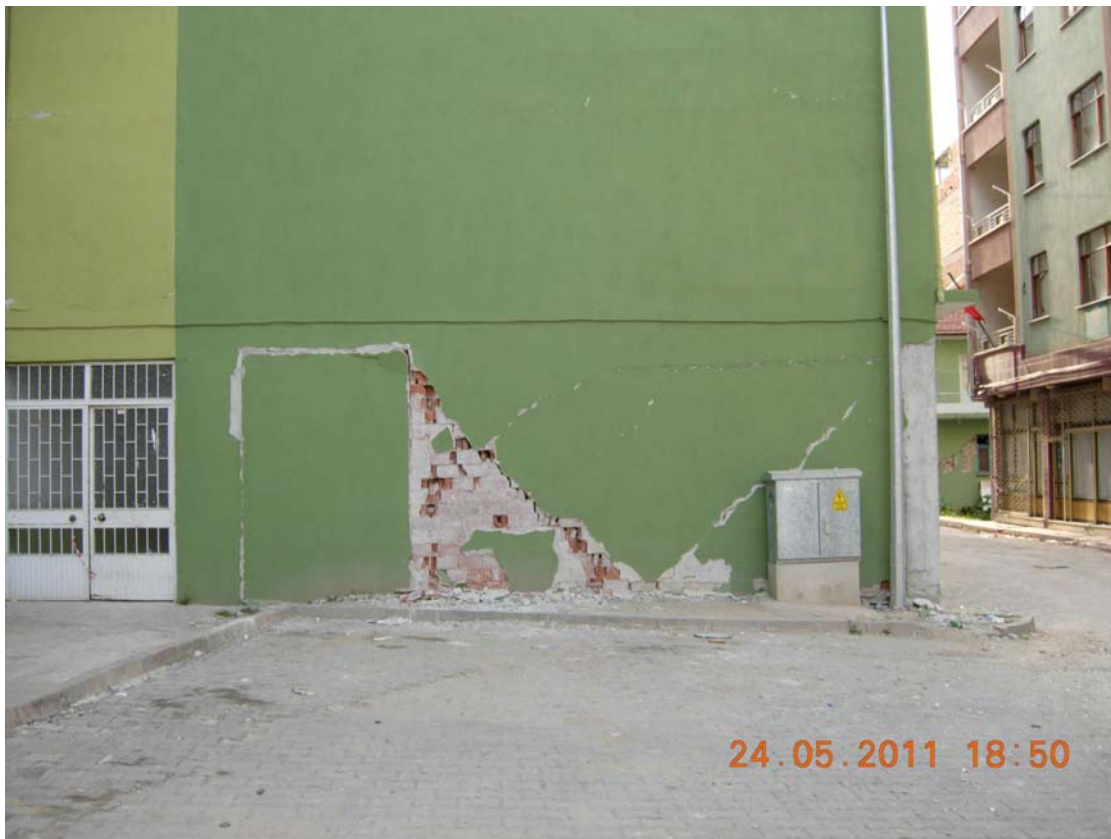
Figure 56: Damaged building, in front of the collapsed building, cracked infill wall at side

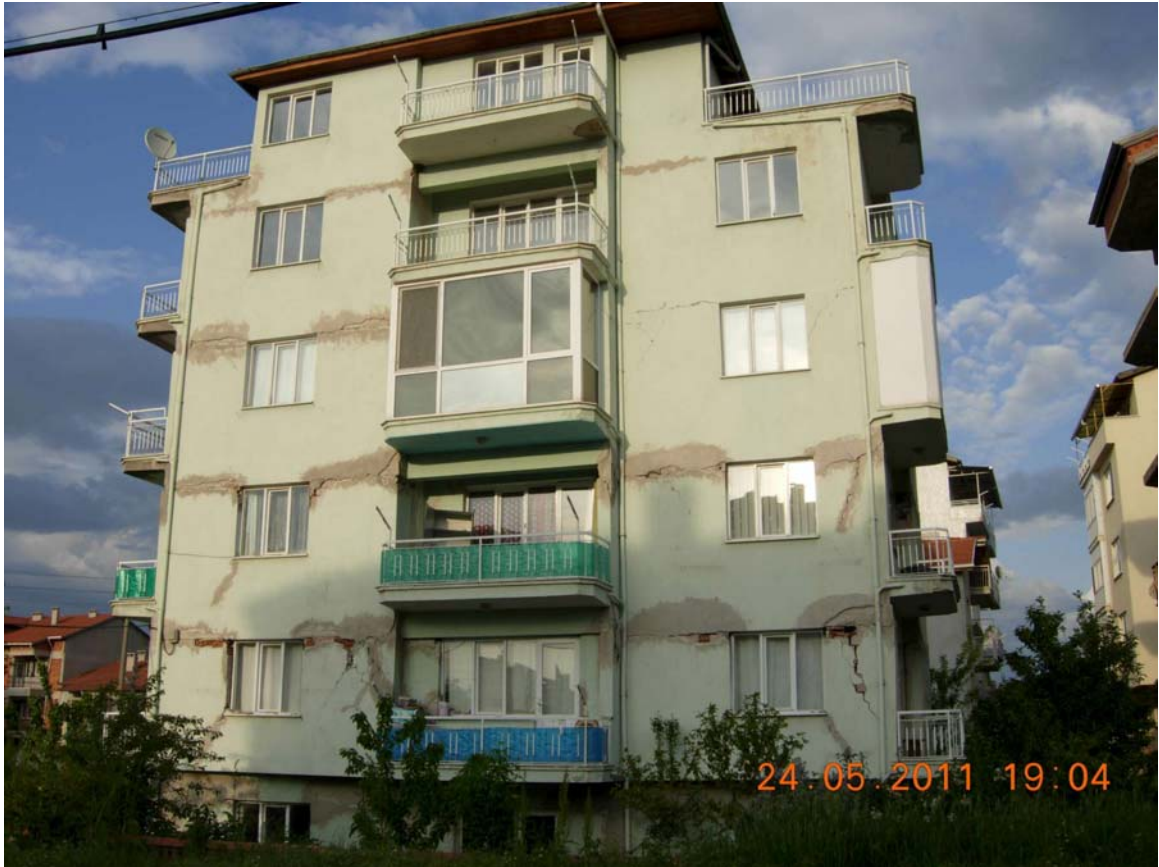
Figure 57: *Damaged building, which was apparently damaged during previous earthquakes, plaster was repaired, but same locations cracked again in this earthquake*

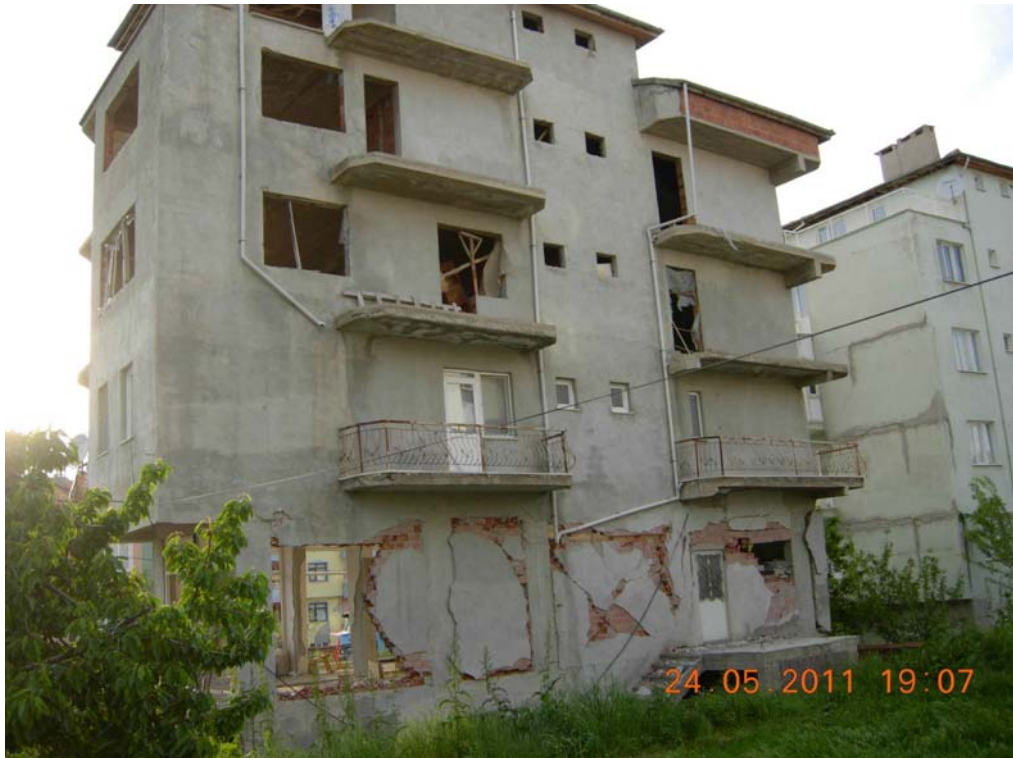
Figure 58: *Non-structural infill wall damage on a new building which is still under construction*

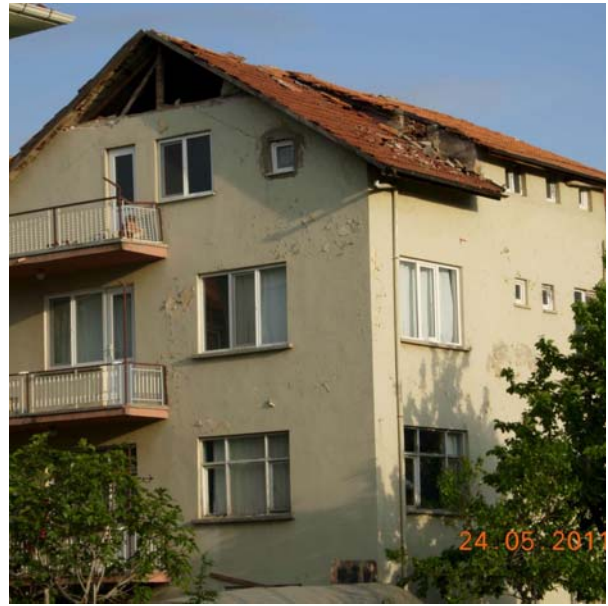
Figure 59: *Roof damage*

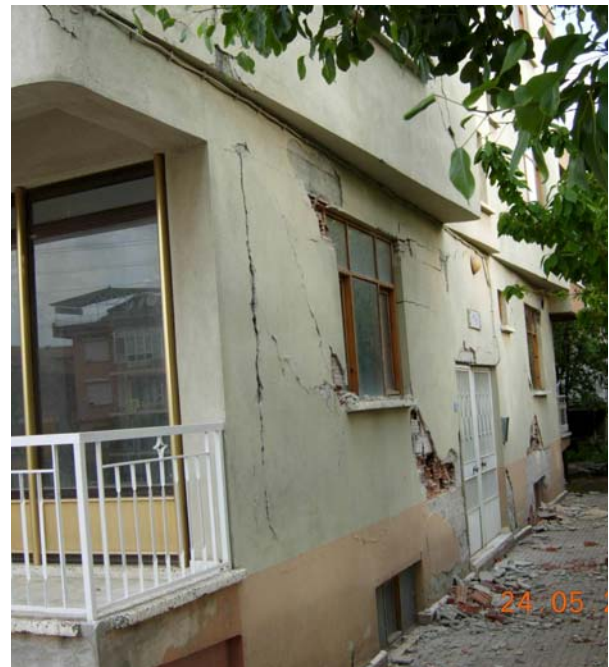
Figure 60: *Infill wall damage, front and side view*

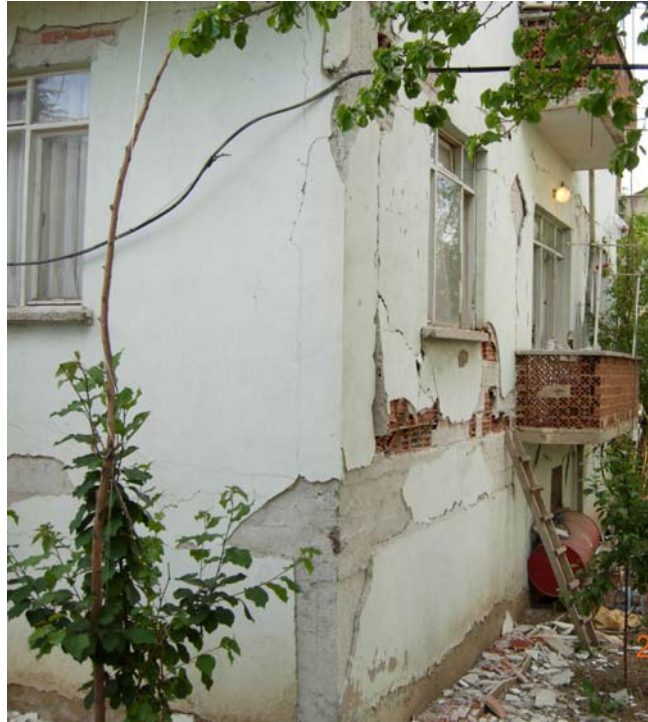
Figure 61: *Infill wall damage and spalling of the plaster of structural members, front and side view*

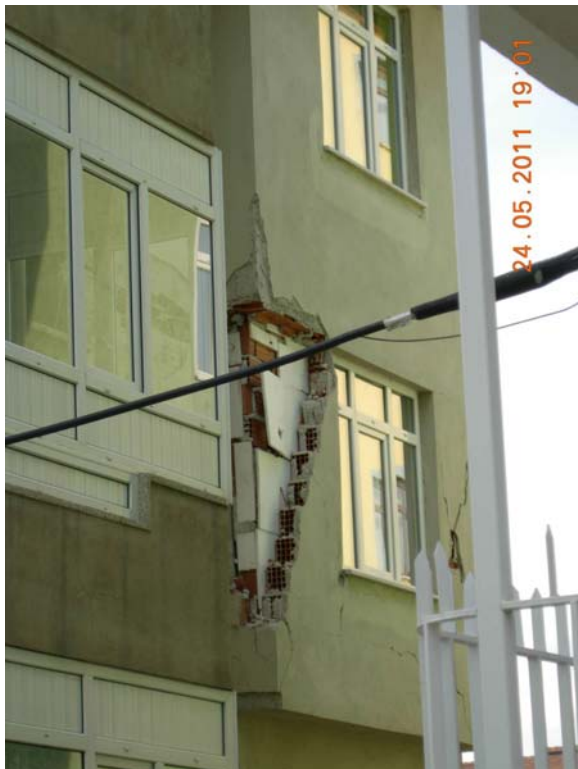
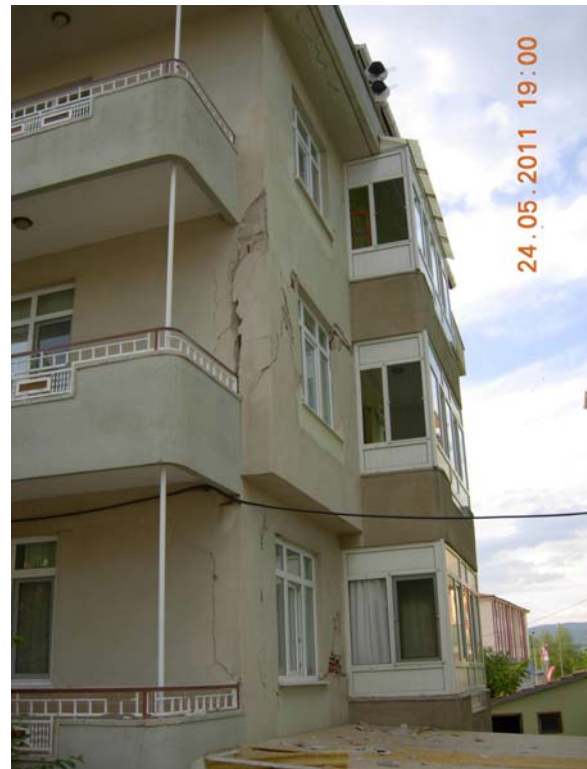
Figure 62: *Damage at outer infill walls*

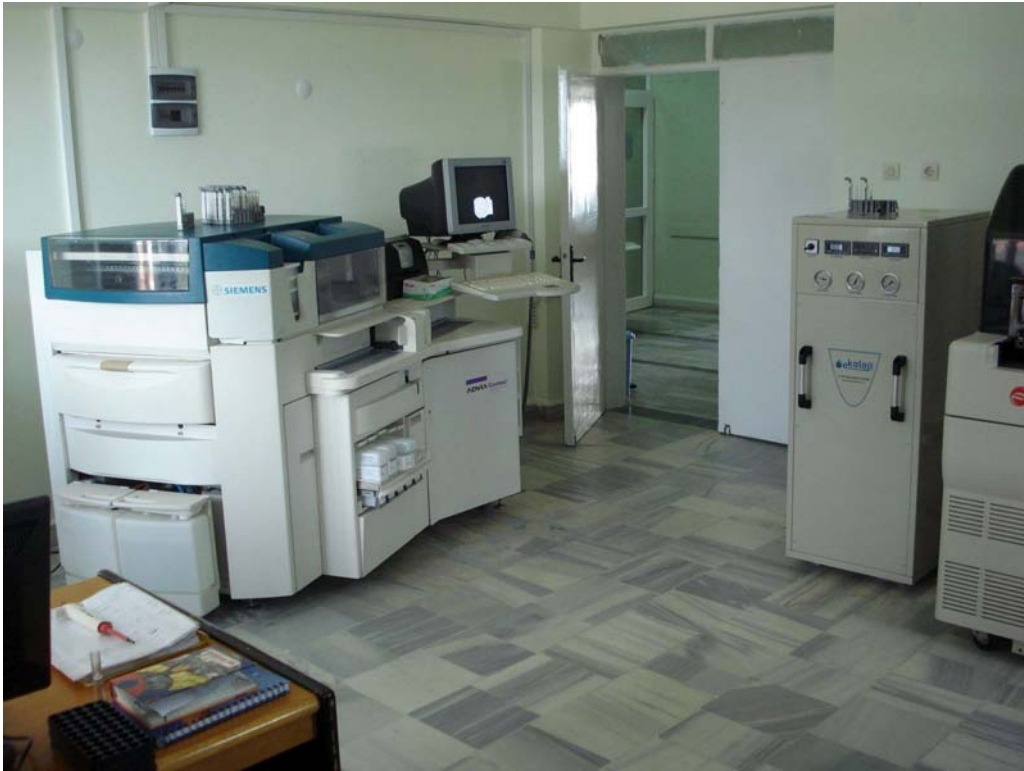
Figure 67: Another building of the hospital complex, which is completed in the beginning of 2000's, biochemistry lab. , all machines have displaced and smaller ones (like monitor) turned over during earthquake

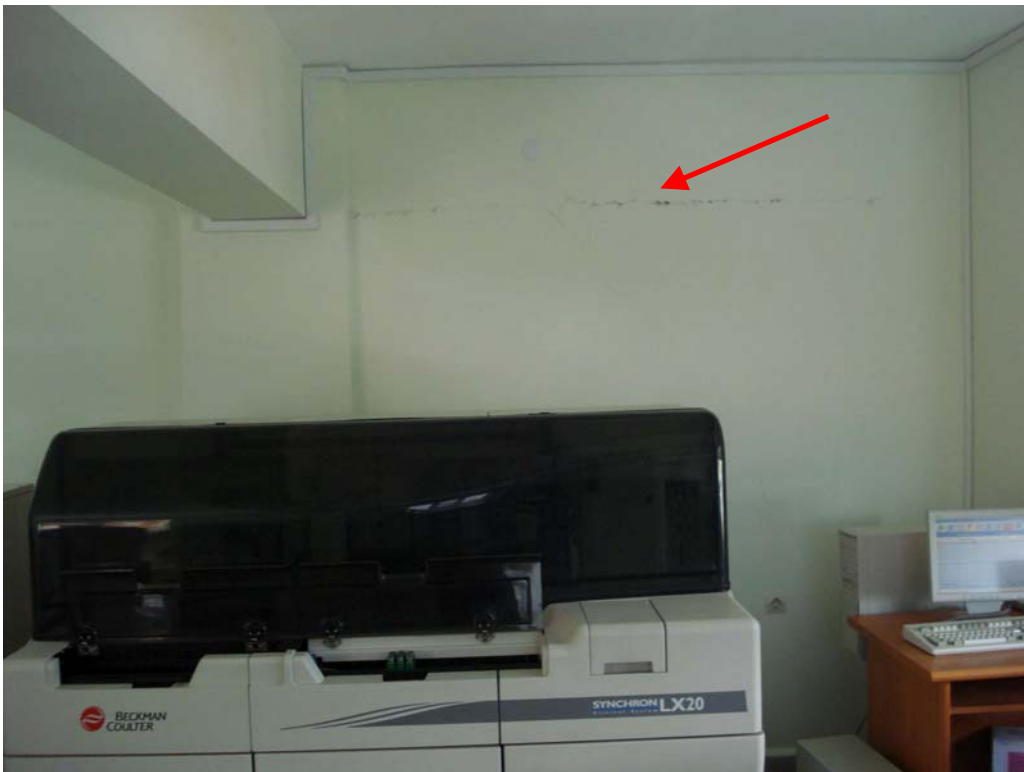
Figure 68: Hospital building, completed in the beginning of 2000's, biochemistry lab. (same room) , machine has displaced, and infill wall cracked during earthquake

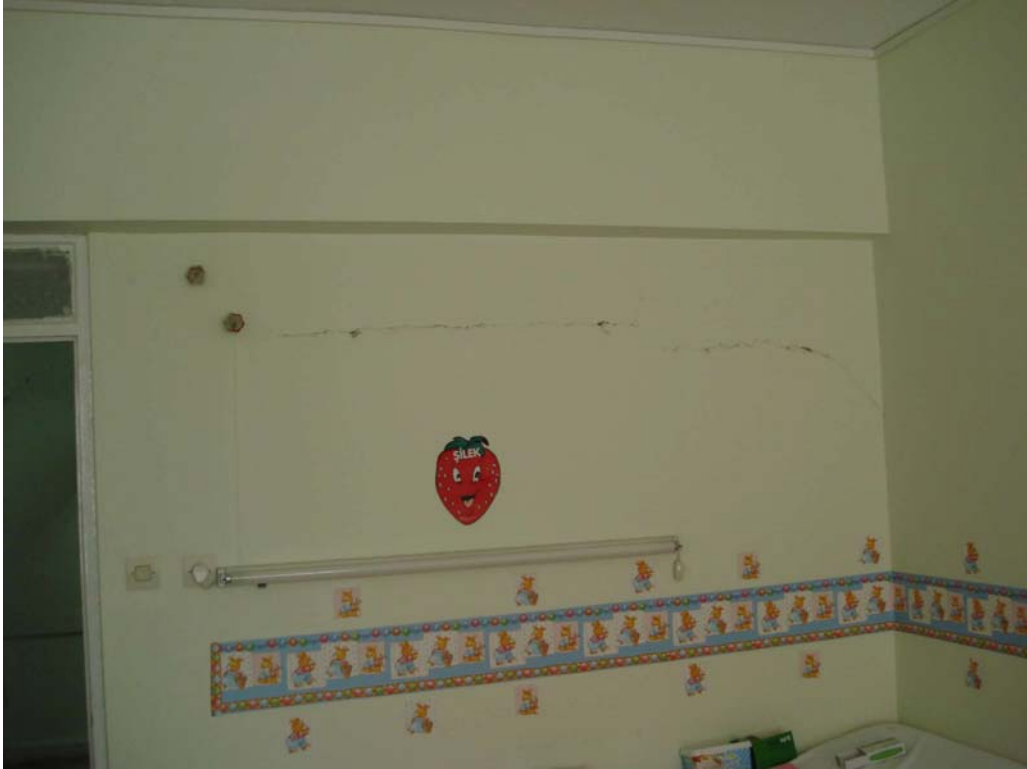
Figure 69: Hospital building, completed in the beginning of 2000's, infill wall crack

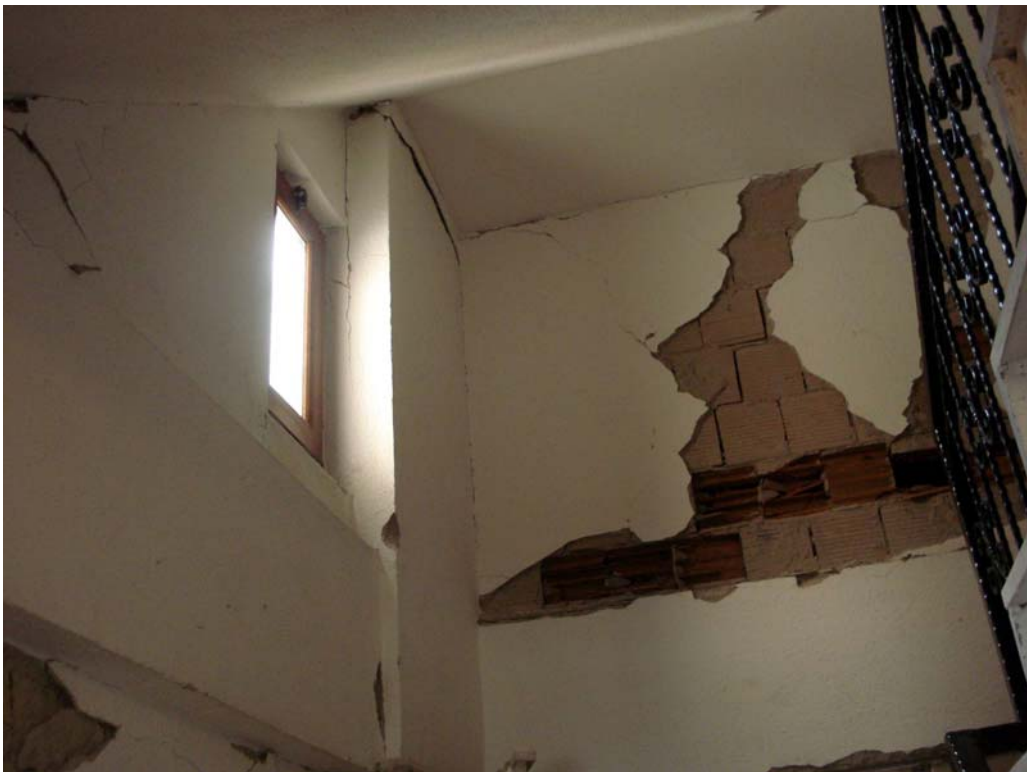
Figure 72: *Building next to hospital complex – staircase infill wall cracks, spalling of plaster*

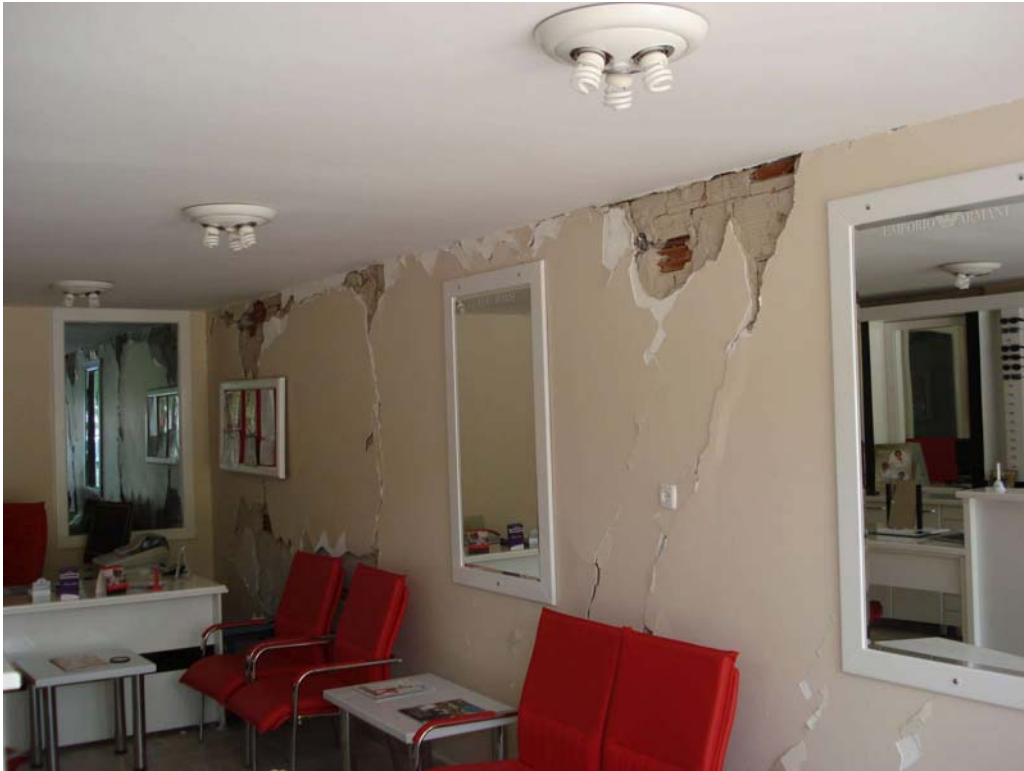
Figure 73: Building next to hospital complex – staircase infill wall cracks, spalling of plaster (ground floor, being used as pharmacy and optician)

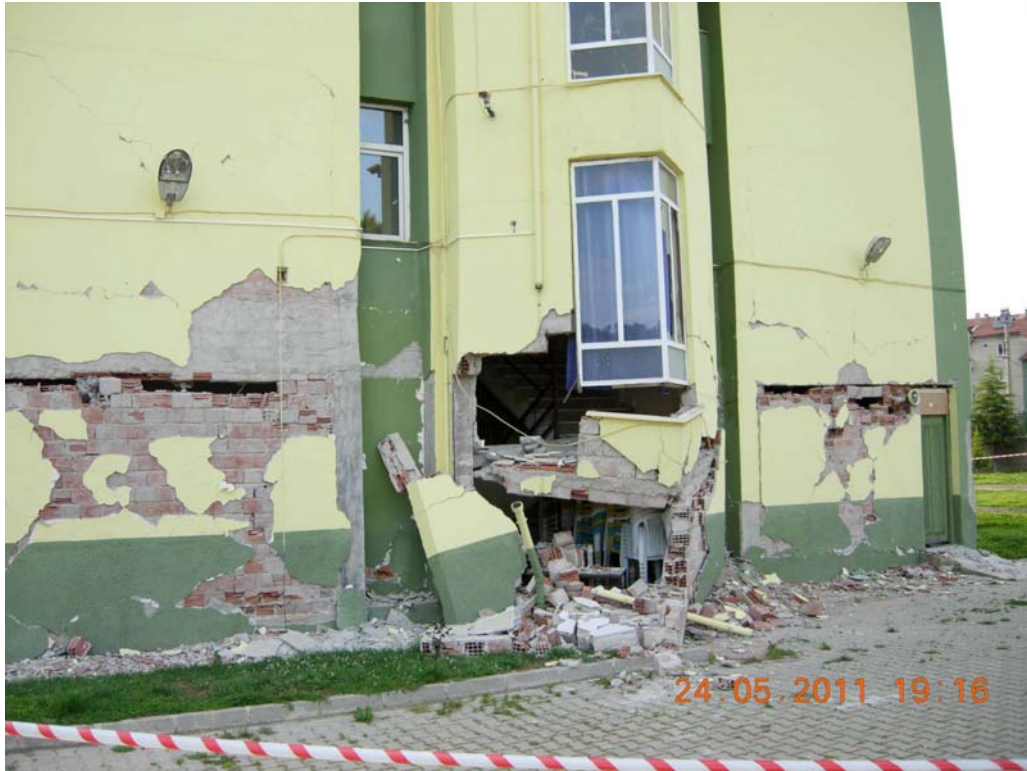
Figure 75: Staircase damage of the RC part of school building, general practice of the territory is to build staircase slabs so thin and without any beam to support the slab

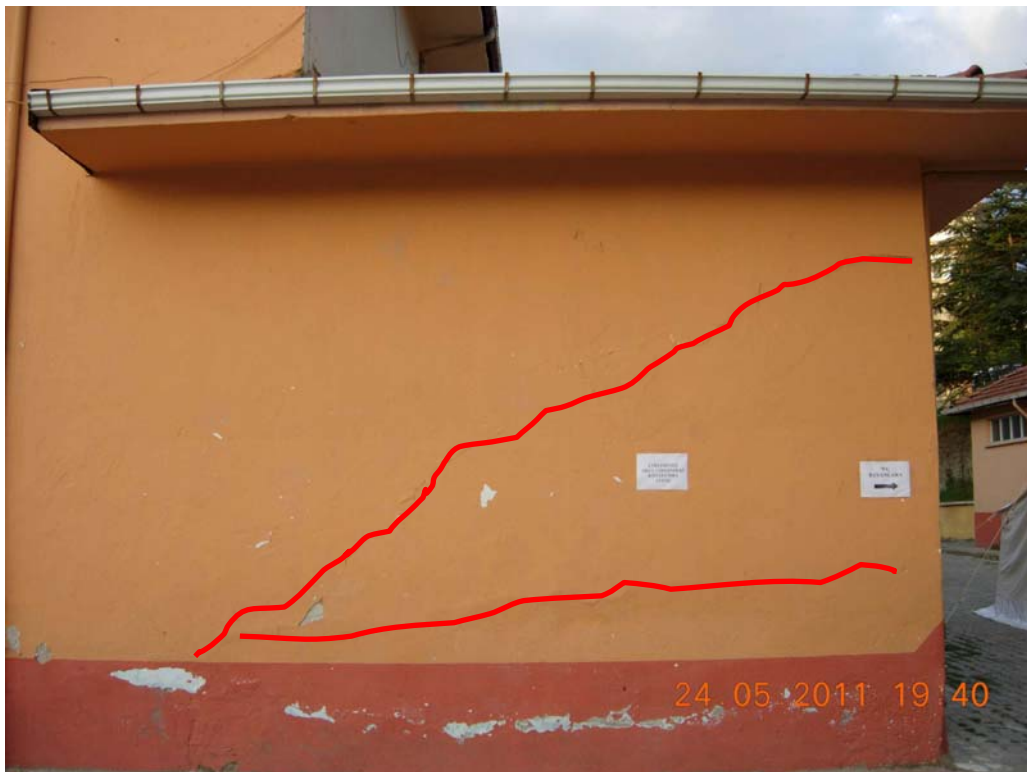
Figure 76: Cracks on outer walls of masonry part of the school building

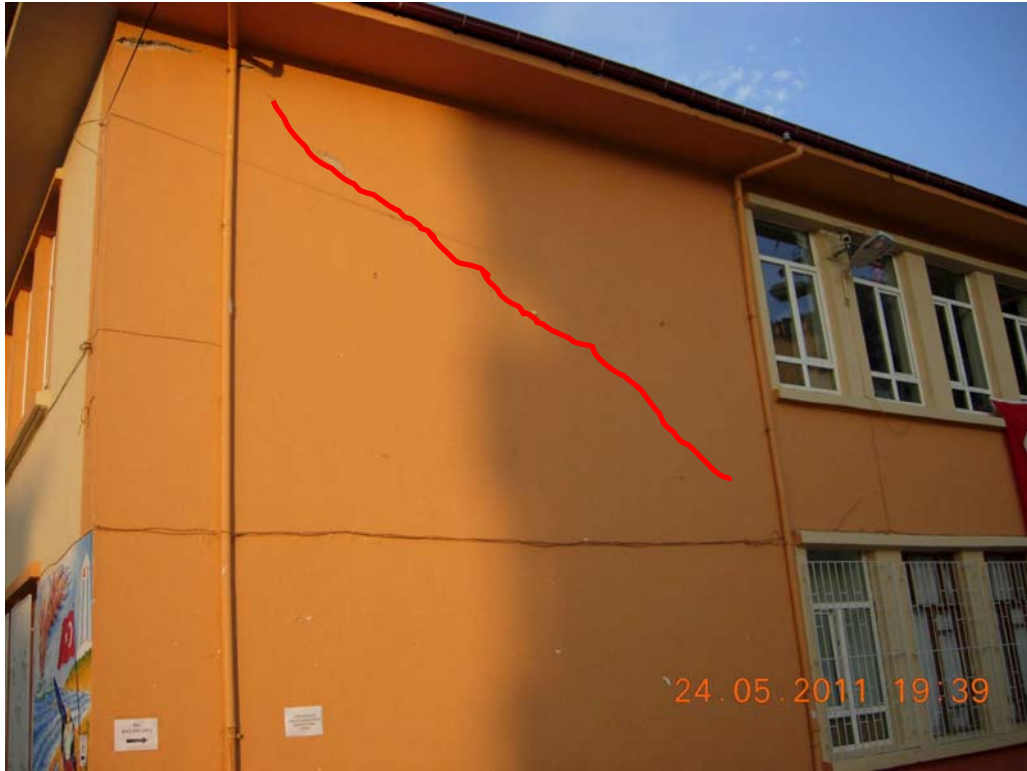
Figure 77: Cracks on outer walls of masonry part of the school building, 2nd floor
