**KANDİLLİ OBSERVATORY AND EARTHQUAKE
RESEARCH INSTITUTE**

***May 19, 2011 KUTAHYA-SIMAV
EARTHQUAKE***

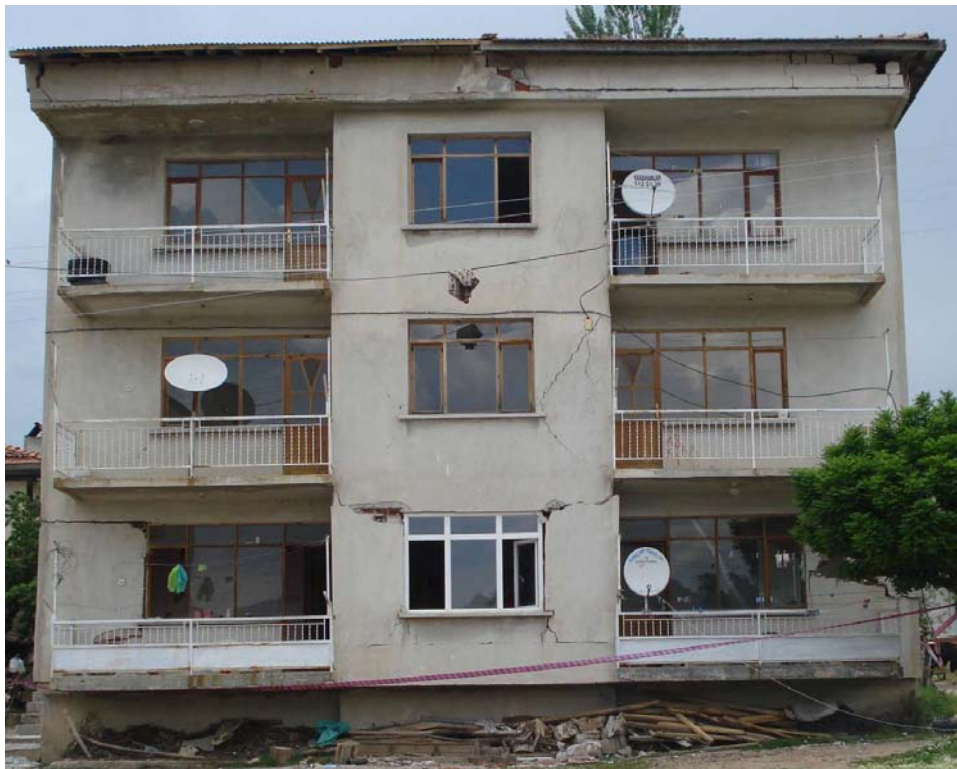
Figure 80: Gökçeler village, grade 3 damaged building, front view

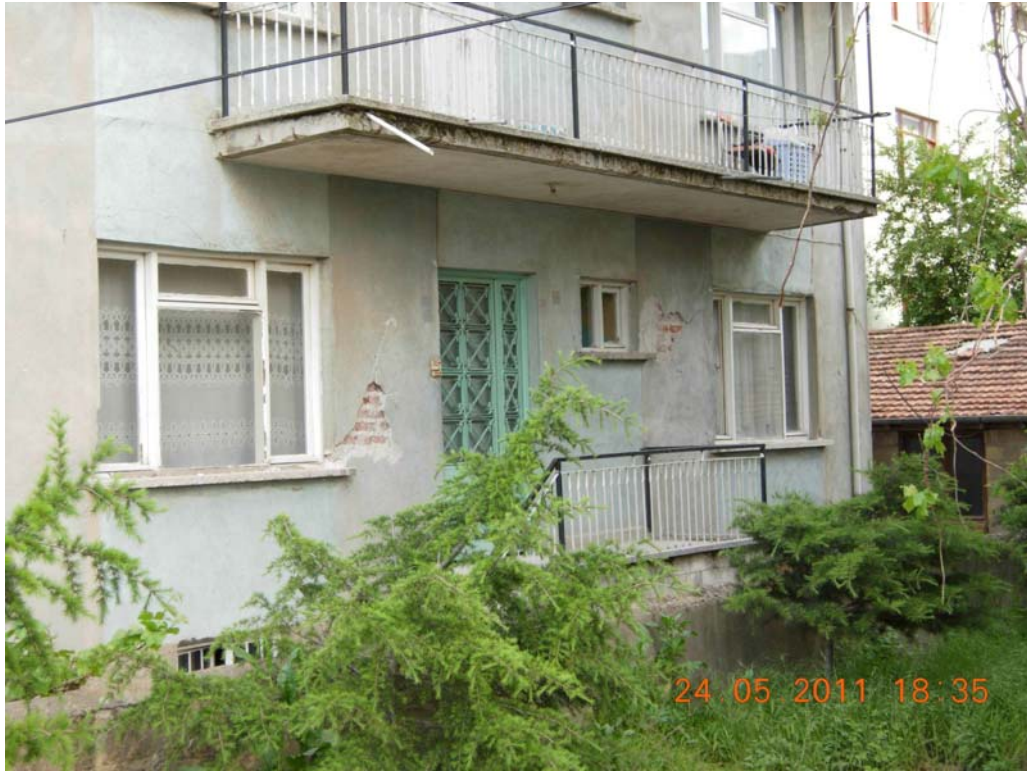
Figure 83: *Spalling of plaster on ground floor of 3 storey brick masonry building*

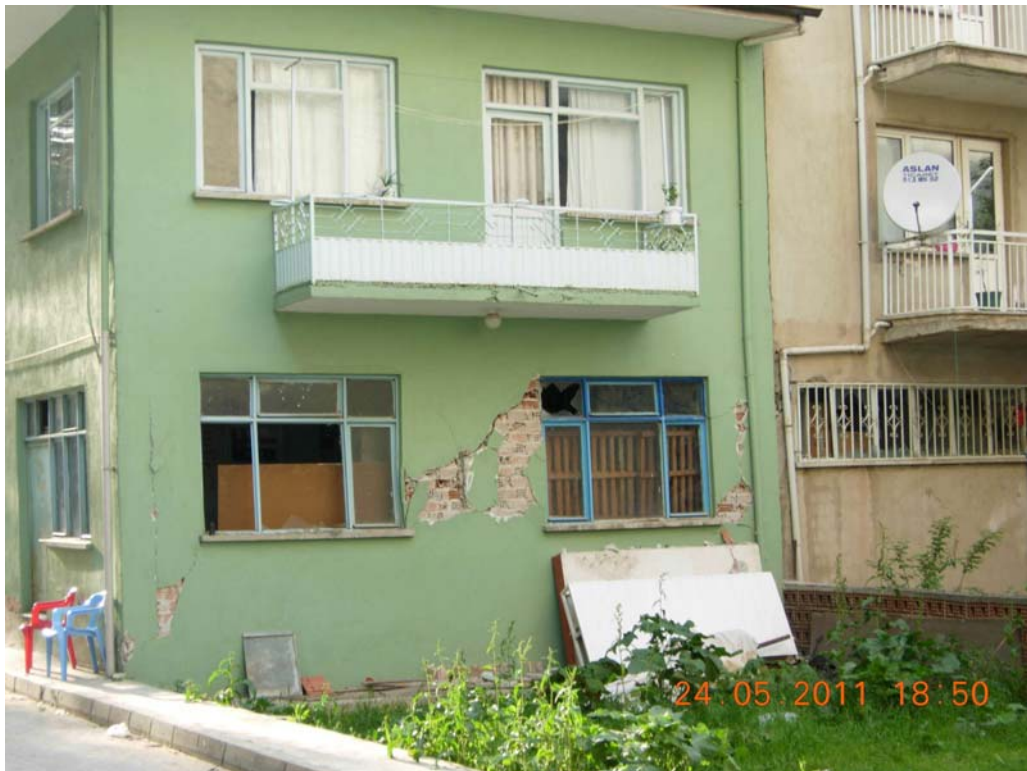
Figure 84: *Spalling of plaster on ground floor of 2 storey brick masonry building*

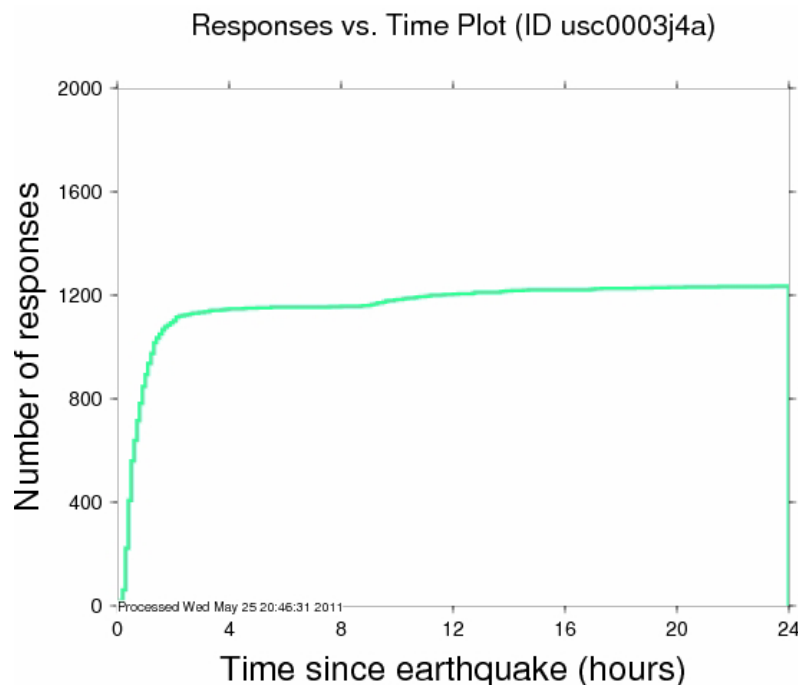
Figure 85: *Number of responses vs time since earthquake*

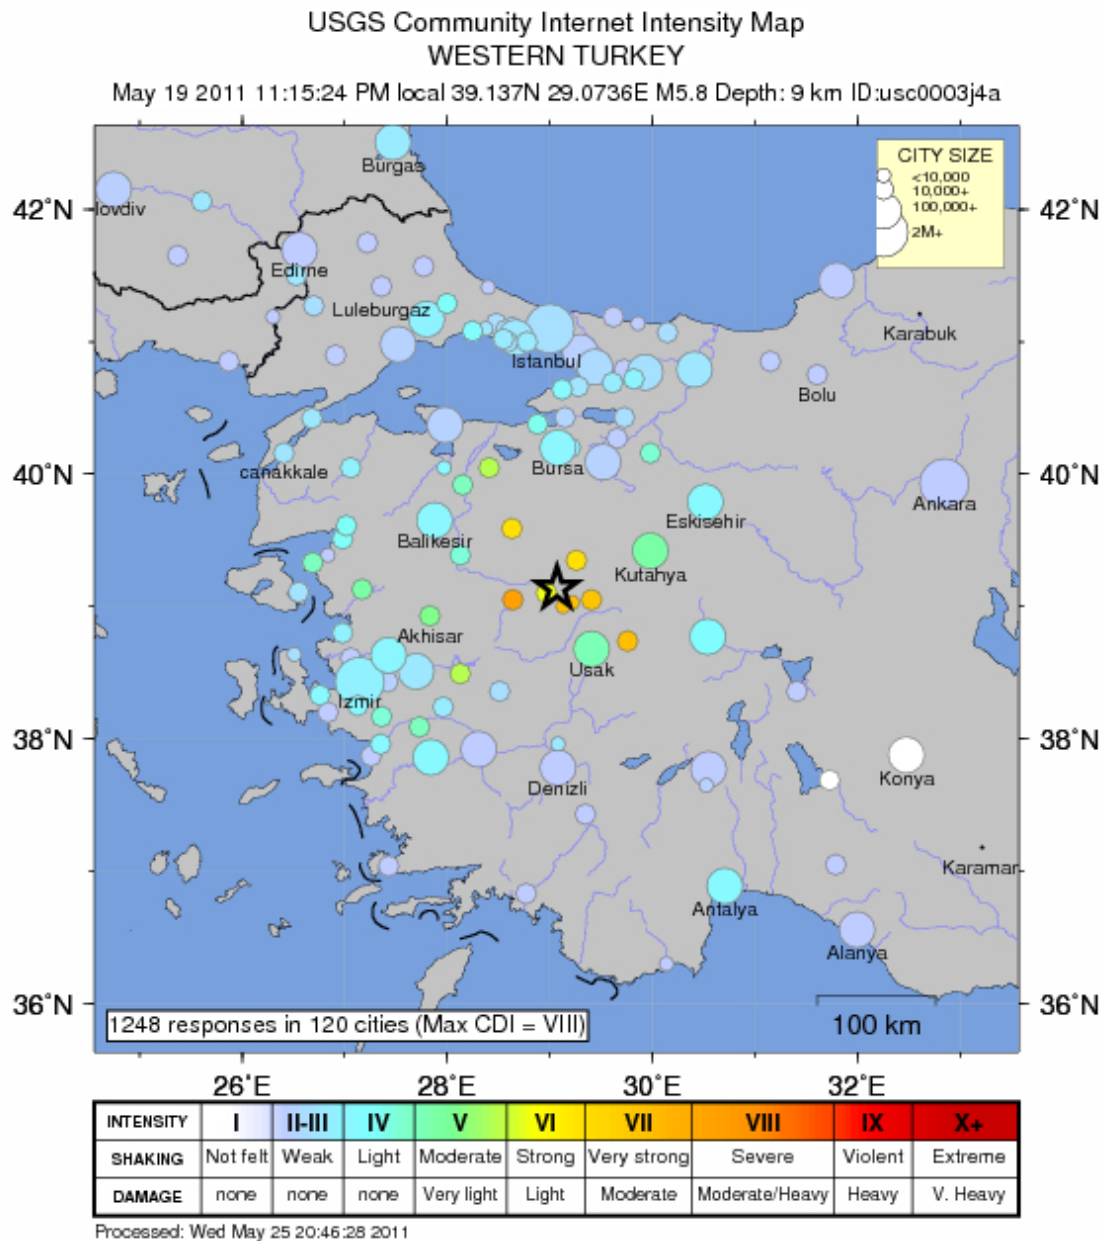
Figure 86: *Distribution of responses with various intensity levels*

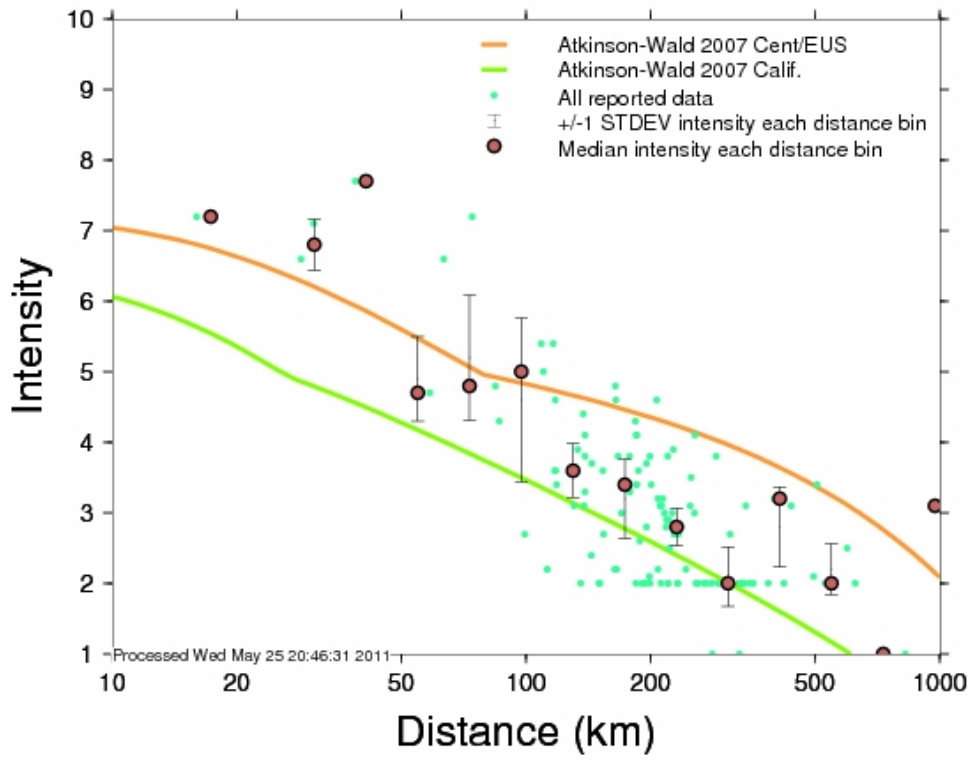
Figure 87: Intensity vs. Distance graph
