Boğaziçi University
Kandilli Observatory and Earthquake Research Institute
Department of Earthquake Engineering

24 January 2020 (20:55)
Elazığ-Sivrice Earthquake

**Seismotectonics, Strong Ground Motion and Building
Damage Estimations
Preliminary Report**

25.01.2020

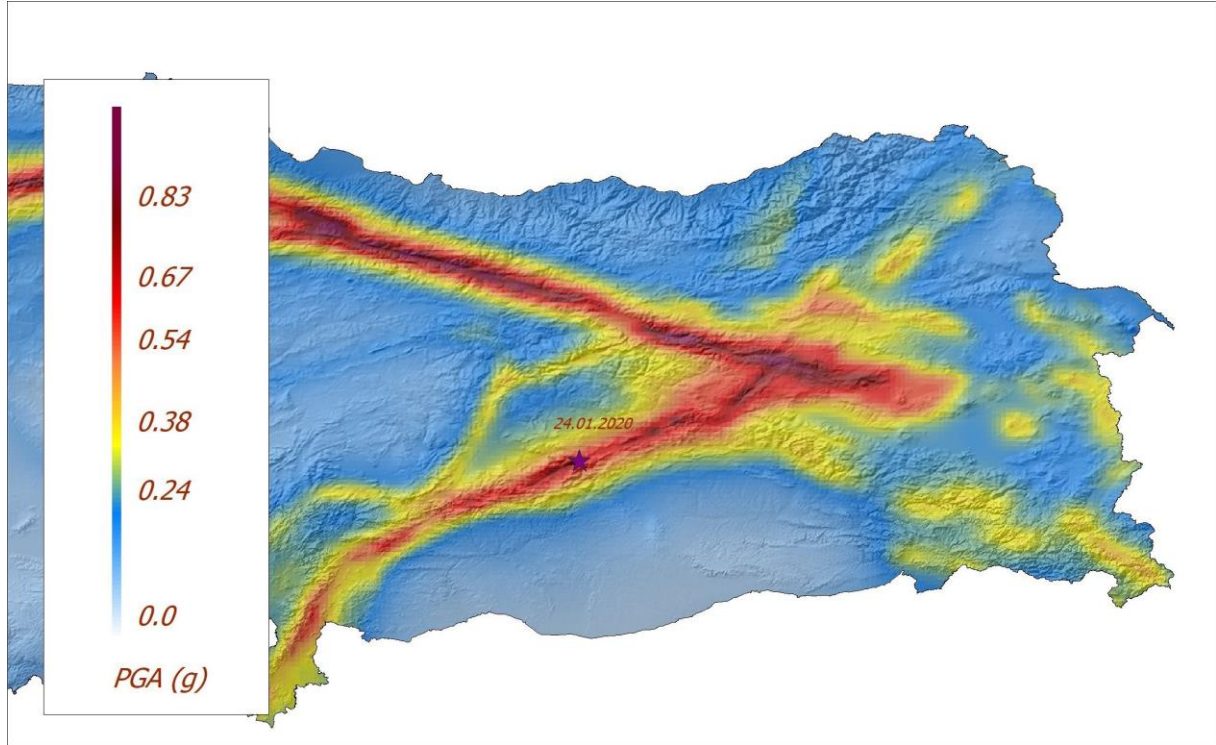
Figure 2. 475 year return period regional PGA distribution according to the recently updated (2018) probabilistic earthquake hazard map of Turkey. The vicinity of the Pütürge segment is associated with PGA values in the order of 0.6 – 0.7 g.

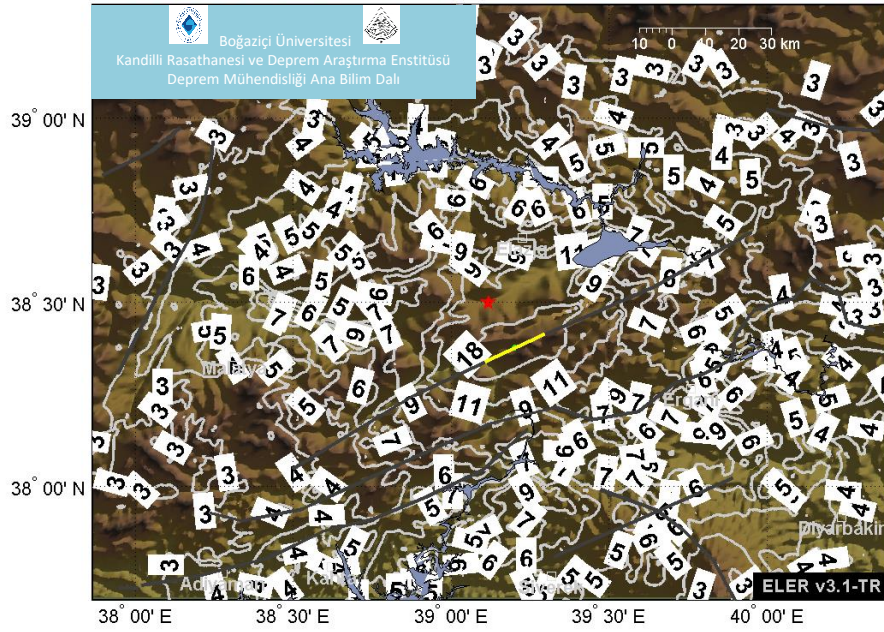
M= 6.5 Derinlik= 4.8 Enlem= 38.498 Boylam= 39.121
PSA10 Haritası (%g)

Figure 6. SA (1.0s) (%g)

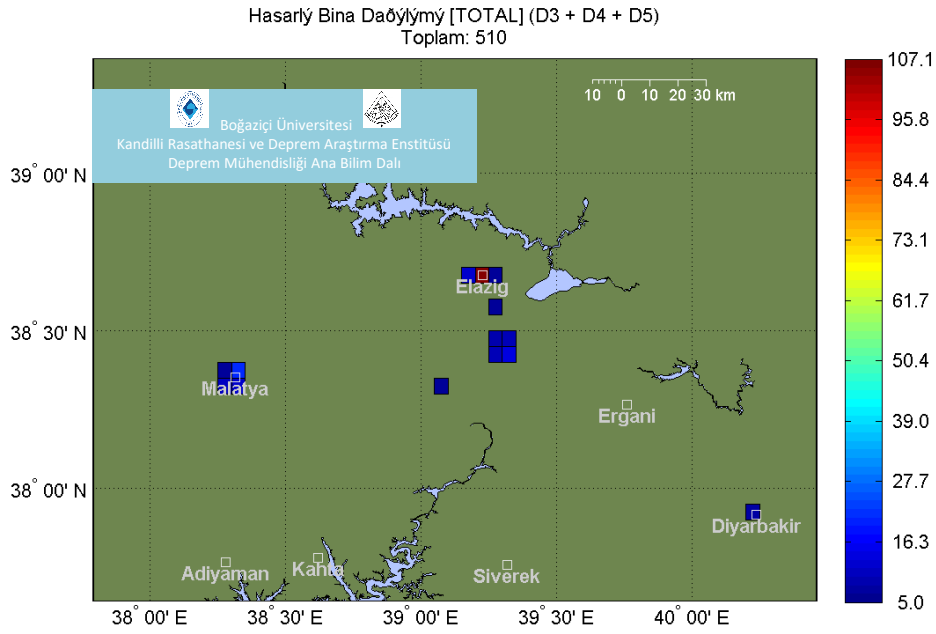
Figure 9. Moderately damaged, heavily damaged and collapsed buildings (D3+D4+D5)

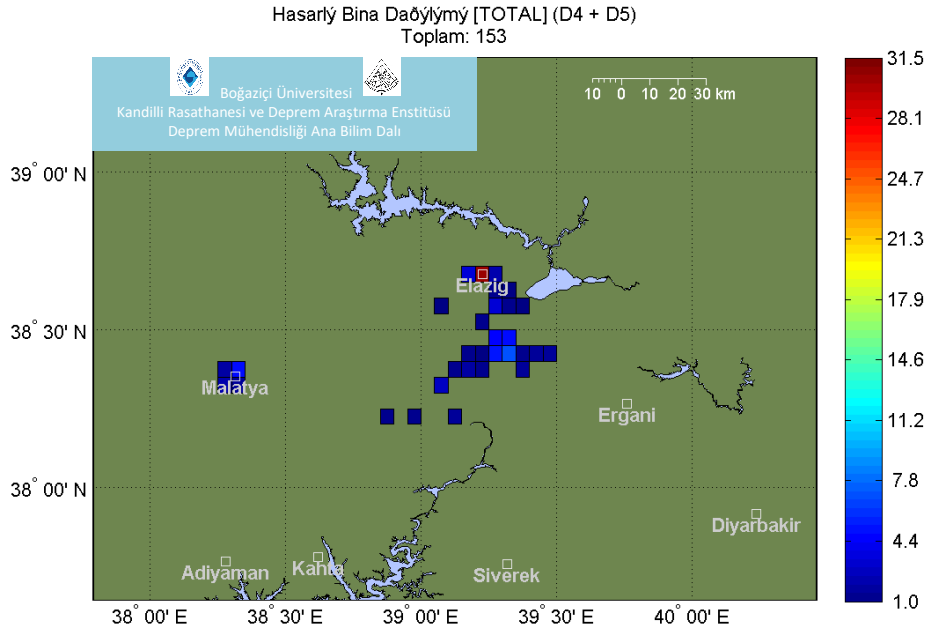
Figure 13. Heavily damaged and collapsed buildings (D4 + D5)

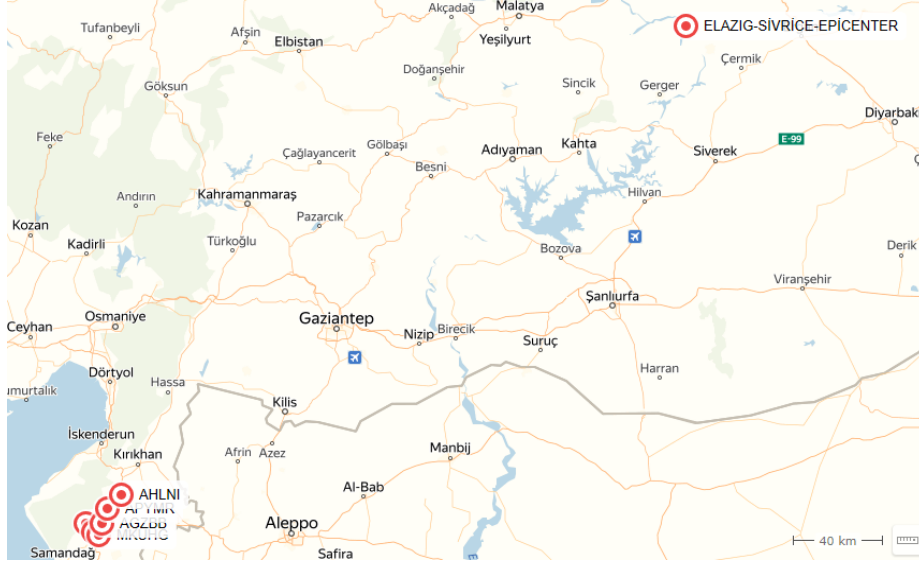
Figure 17. Epicenter of the Elazığ-Sivrice earthquake and the Antakya Basin Strong Motion Monitoring System

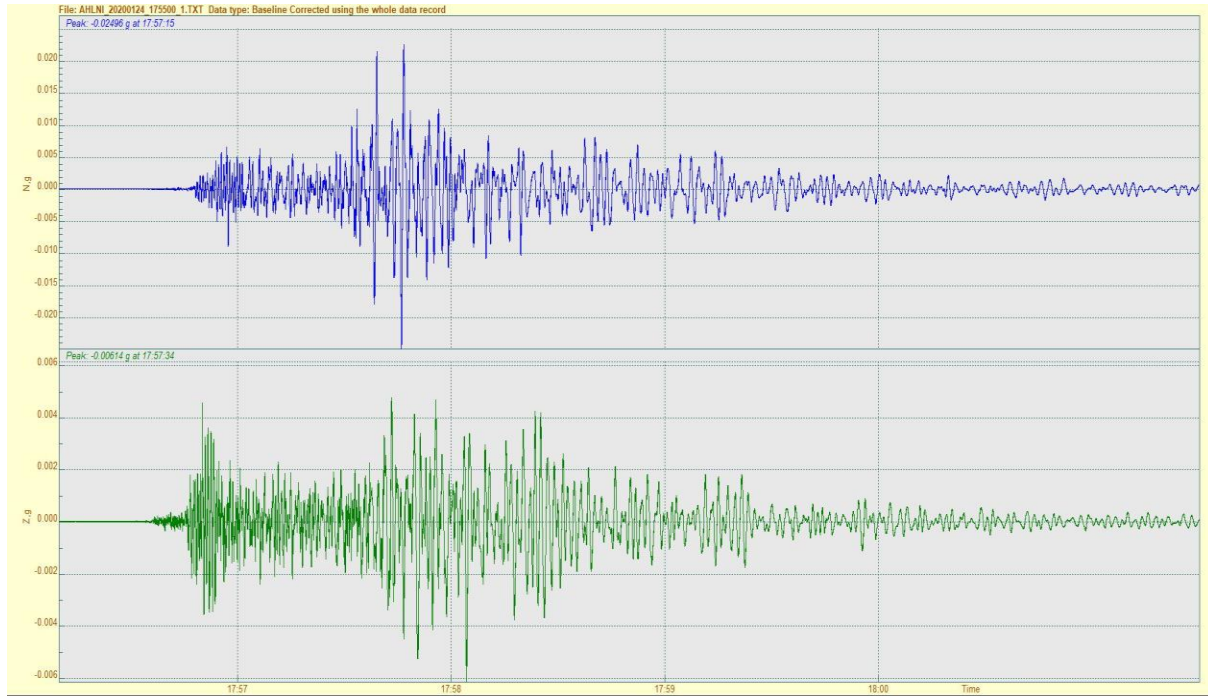
Figure 19. AHLNI station, raw accelerations

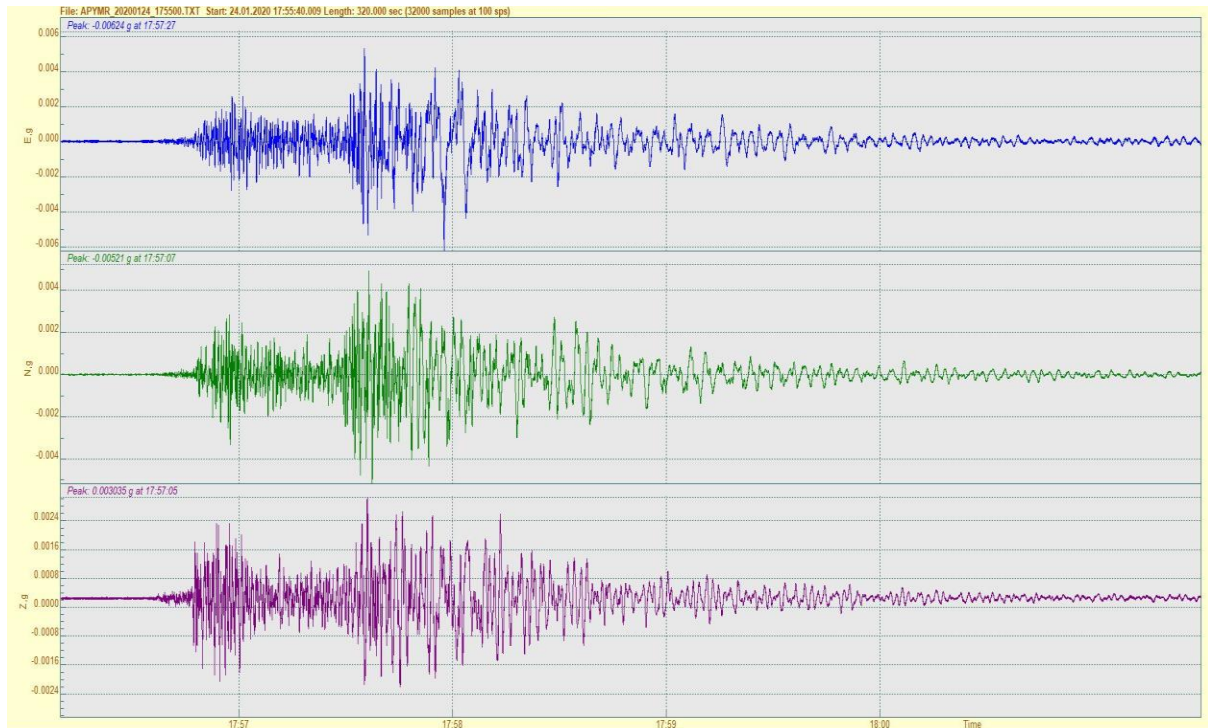
Figure 20. APYMR station, raw accelerations

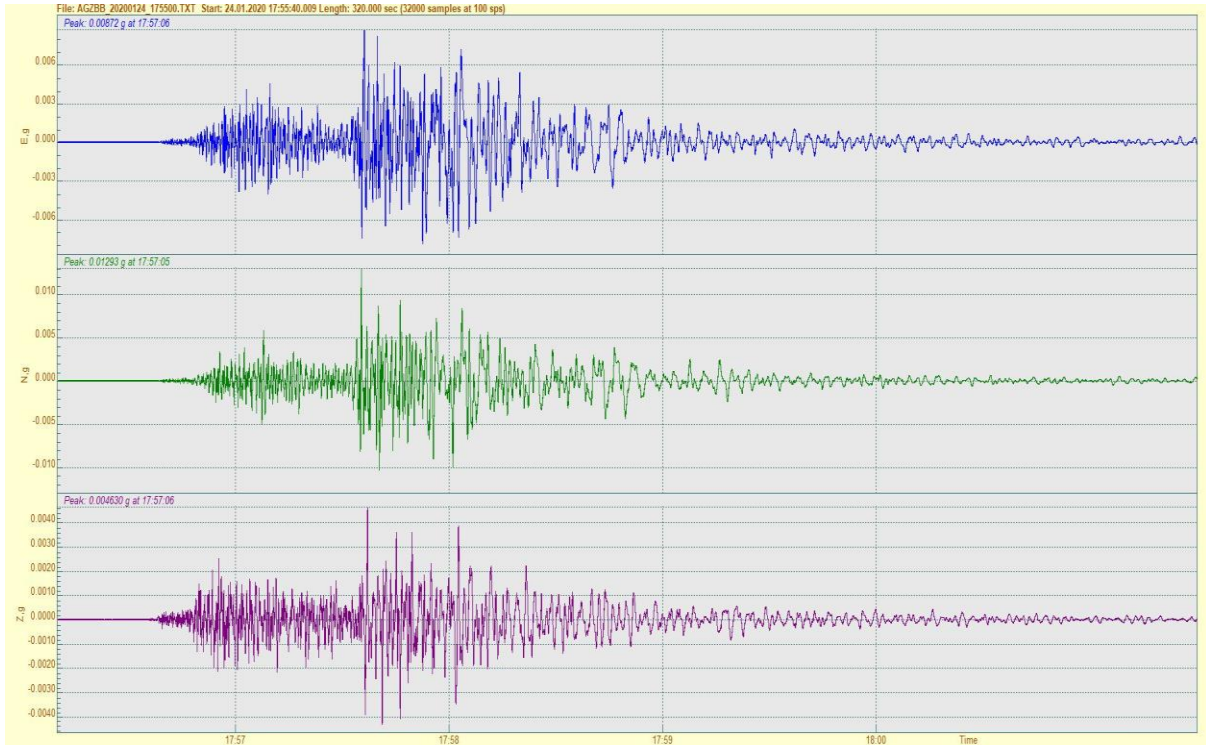
Figure 21. AGZBB station, raw accelerations

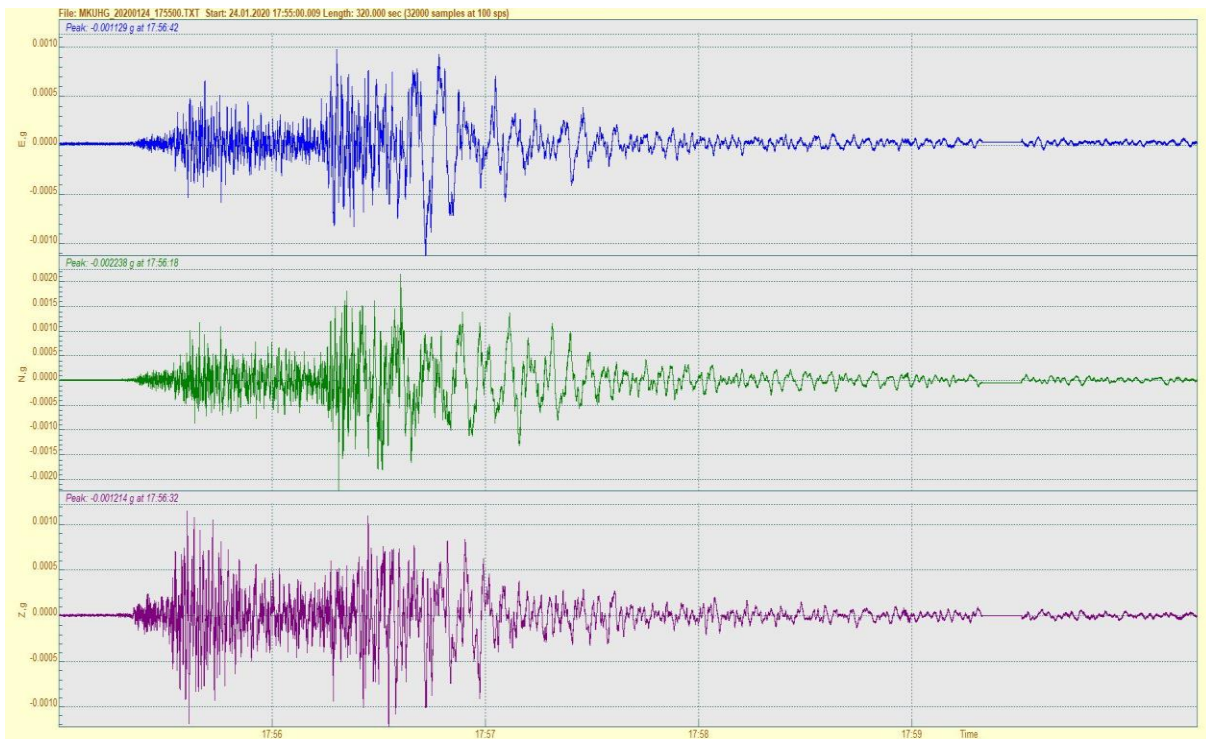
Figure 22. MKUHG station, raw accelerations

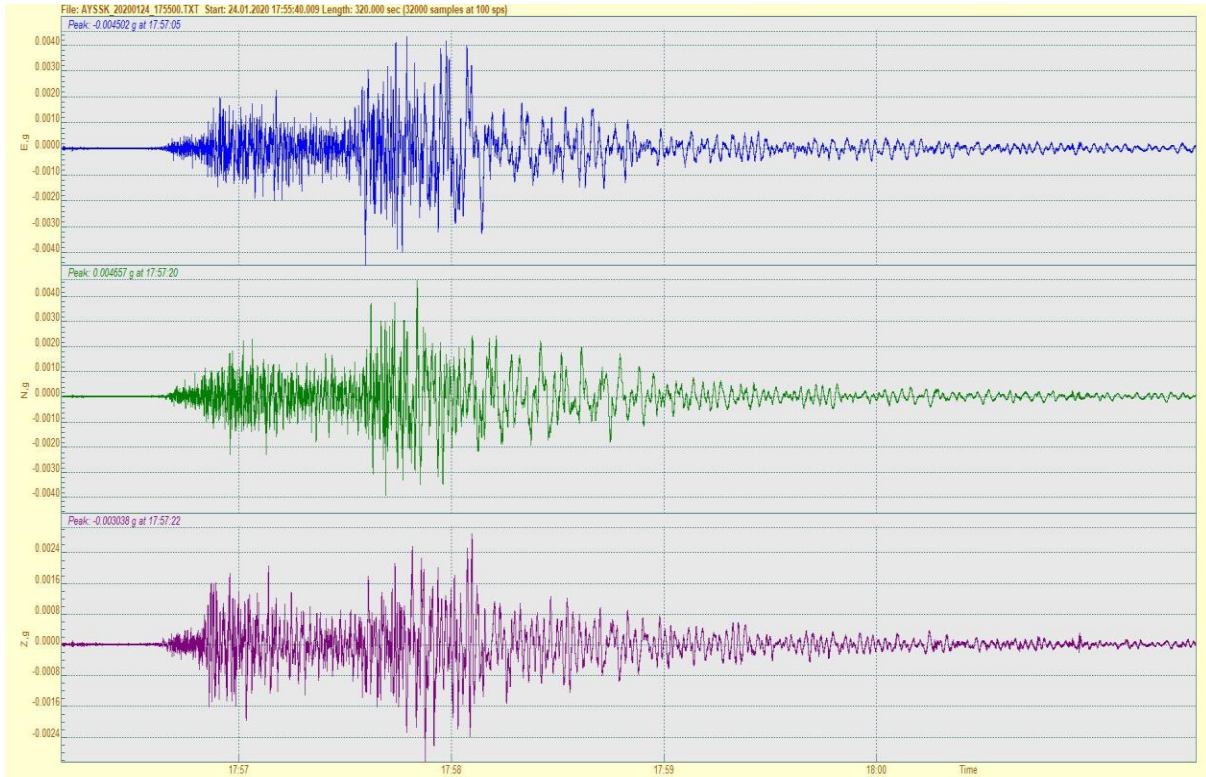
Figure 23. AYSSK station, raw accelerations

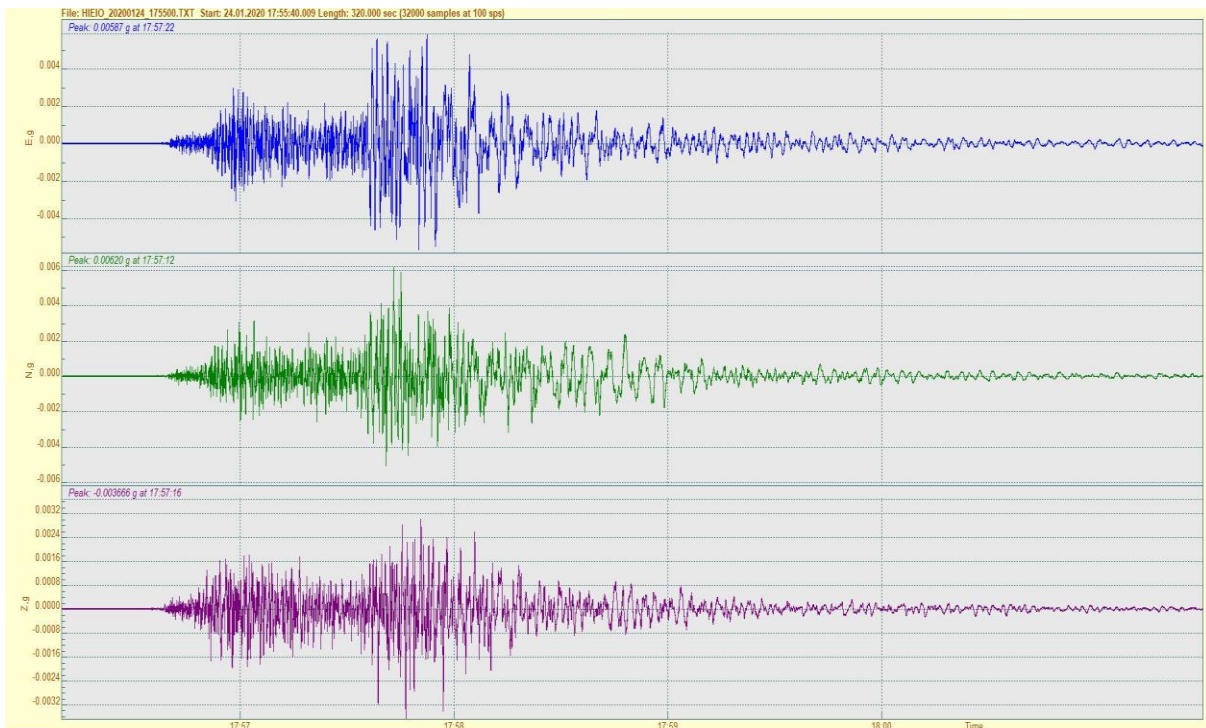
Figure 24. HIEIO station, raw accelerations

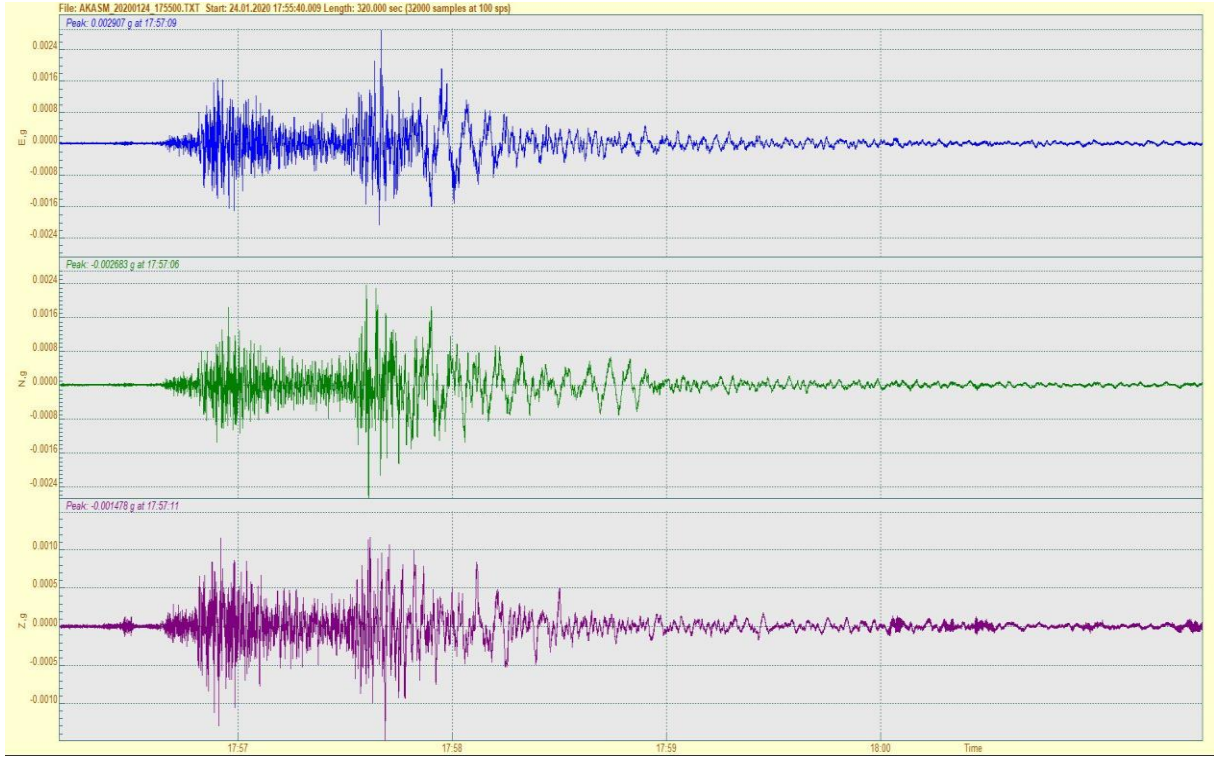
Figure 25. AKASM station, raw accelerations

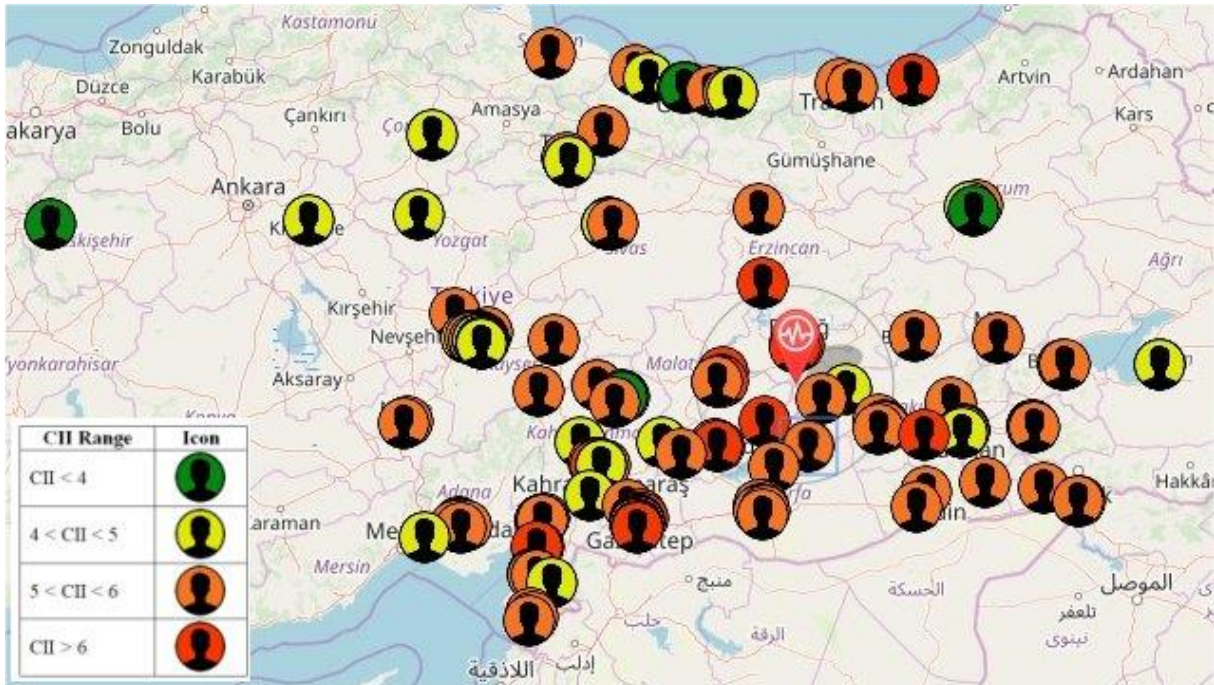
Figure 26. Feedback by the users of the Earthquake Information System 3.0 (324 reports). First report was received at 21:17 local time, approximately 20 min after the earthquake.

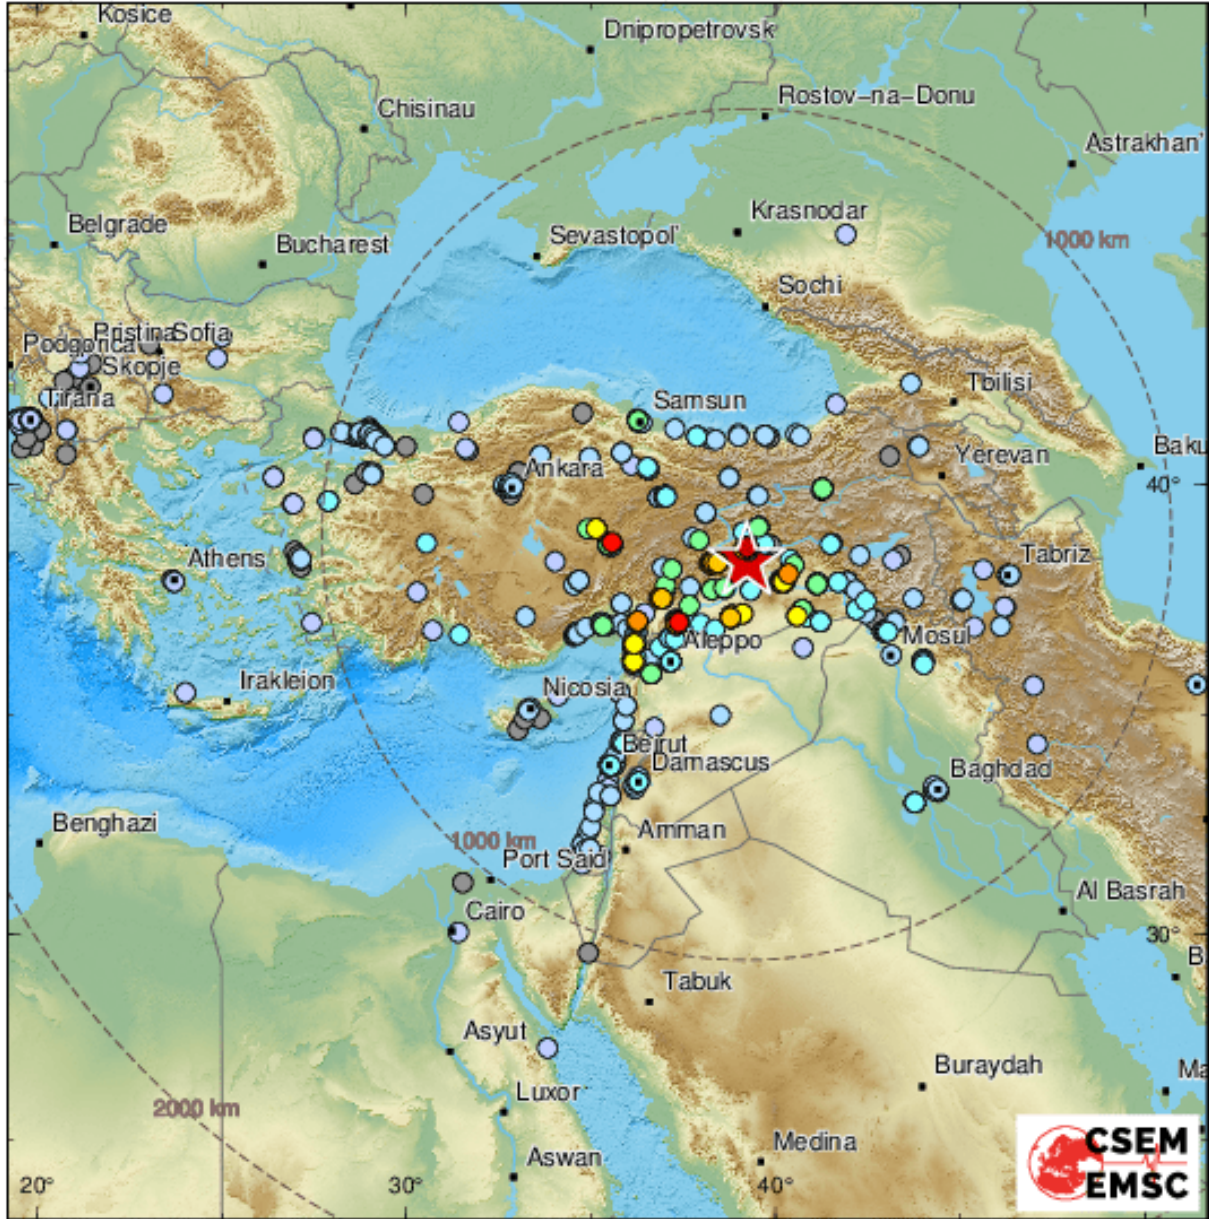
832 feltreports on this map

Figure 27. Reported intensities over the EMSC LastQuake Application
